**REPORT OF PHASE I  
ENVIRONMENTAL SITE ASSESSMENT  
SALISBURY MALL SITE  
SALISBURY, NORTH CAROLINA  
ESP PROJECT NO. E6-BW06.600**

Reference: **REPORT OF PHASE I ENVIRONMENTAL SITE ASSESSMENT**  
**Salisbury Mall Site**  
Salisbury, North Carolina  
ESP Project No. E6-BW06.600

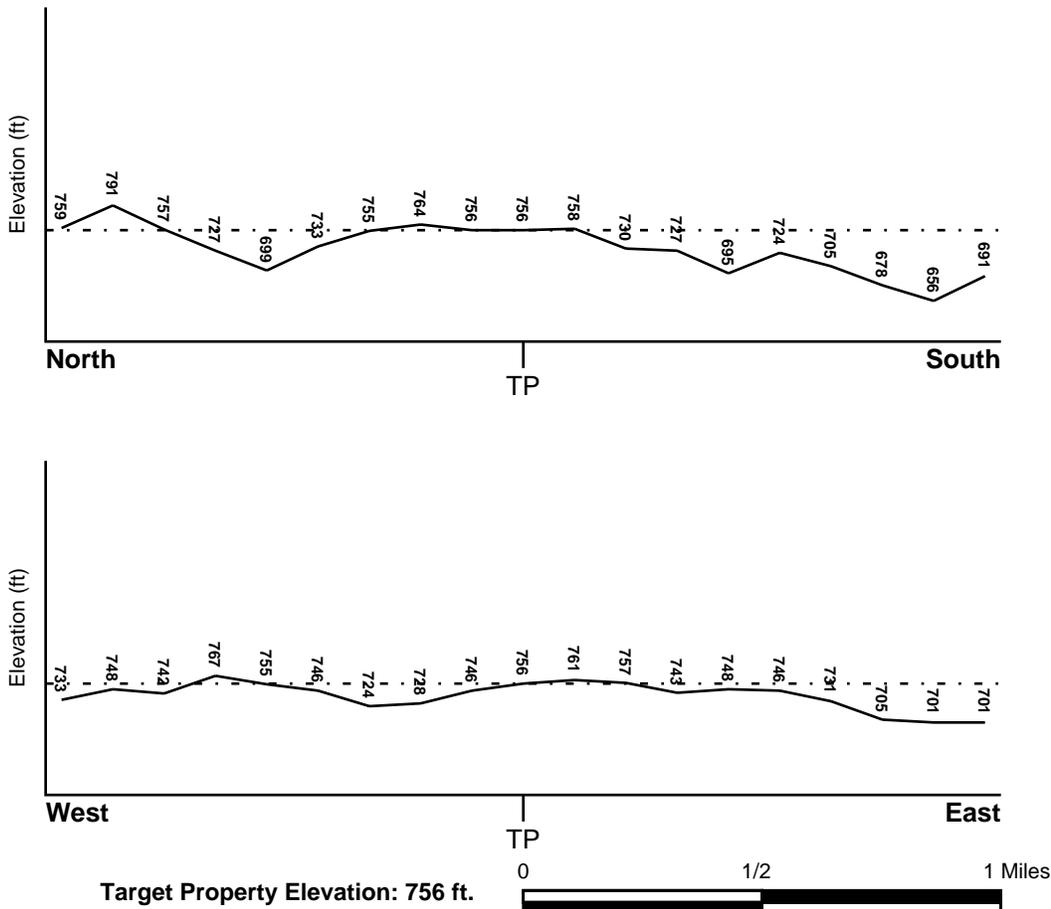
## SURROUNDING TOPOGRAPHY: ELEVATION PROFILES

Source: Topography has been determined from the USGS 7.5' Digital Elevation Model and should be evaluated on a relative (not an absolute) basis. Relative elevation information between sites of close proximity should be field verified.

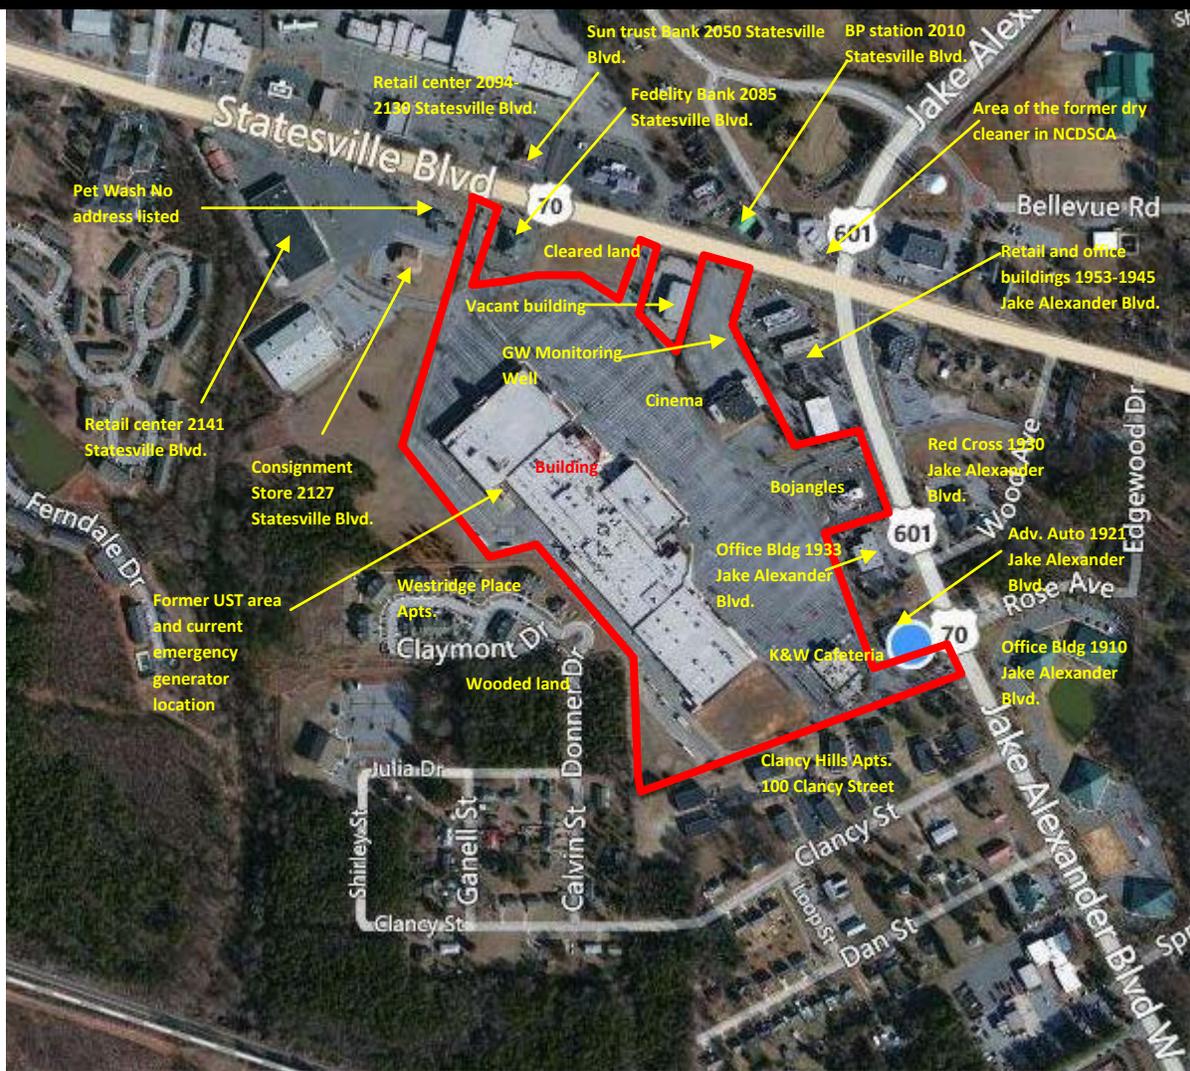
↙  
**Groundwater flow  
 on site**

**SITE PLAN**  
**Salisbury Mall**  
**1921-1951 Jake Alexander Blvd.**  
**Salisbury, North Carolina 28147**

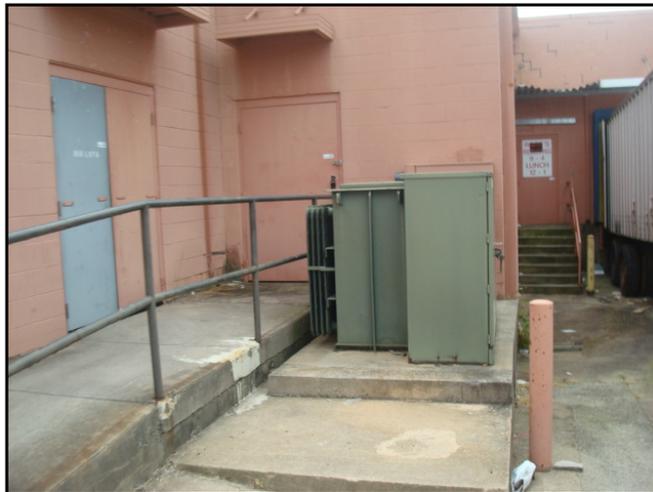
Electrical transformers are a potential source of environmental concern due to the presence of coolant oils that may contain polychlorinated biphenyl (PCB) compounds in older transformers. During the site walkthrough, ESP observed six pole-mounted transformers on two poles and seven pad-mounted transformers across the site. Based on the lack of indications of a release on the transformers or on the ground beneath the transformers, ESP does not consider their presence to be a REC.

Transformer (typical)

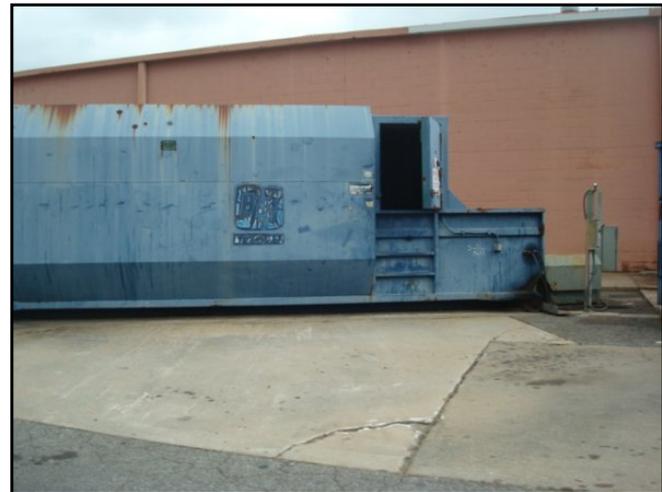
Compactor at rear of mall building

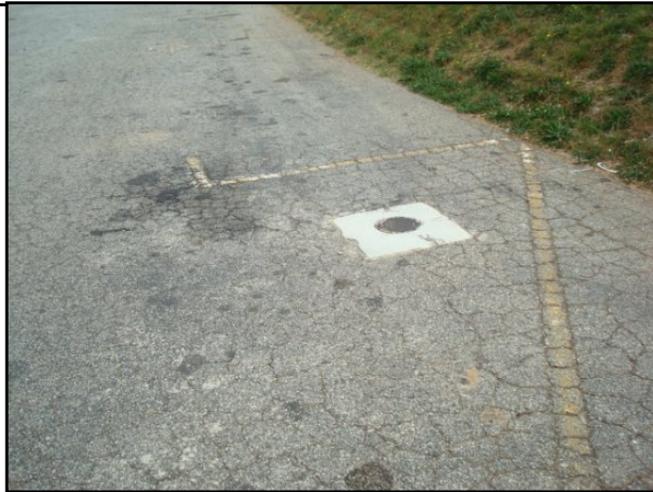
No other environmental concerns were noted during the exterior site walkthrough, interviews, or database search with the exception of the presence of two monitoring wells located on the northern portion of the site. The monitoring wells are reported to be associated with a drycleaner release from the former Highlander Center Laundry and a petroleum release from the Country Cupboard station, both located across Statesville Boulevard and either hydraulically upgradient or crossgradient of the site. Based on interviews and available documents, ESP does not consider the former drycleaner and petroleum releases to be a REC based on their regulatory status.

Monitoring well near cinema building

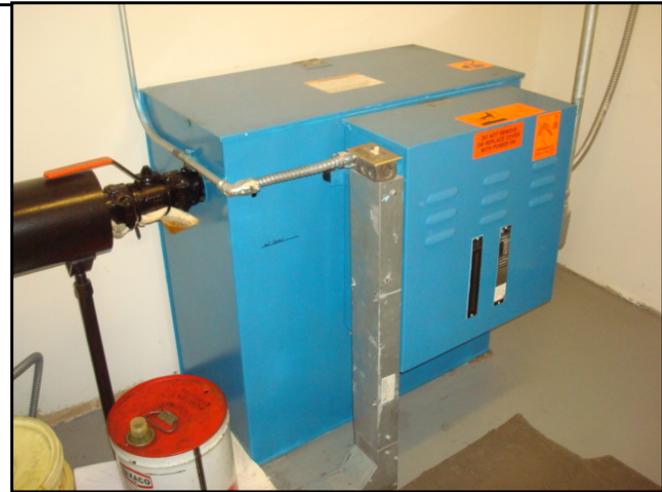
Elevator equipment room at Belk

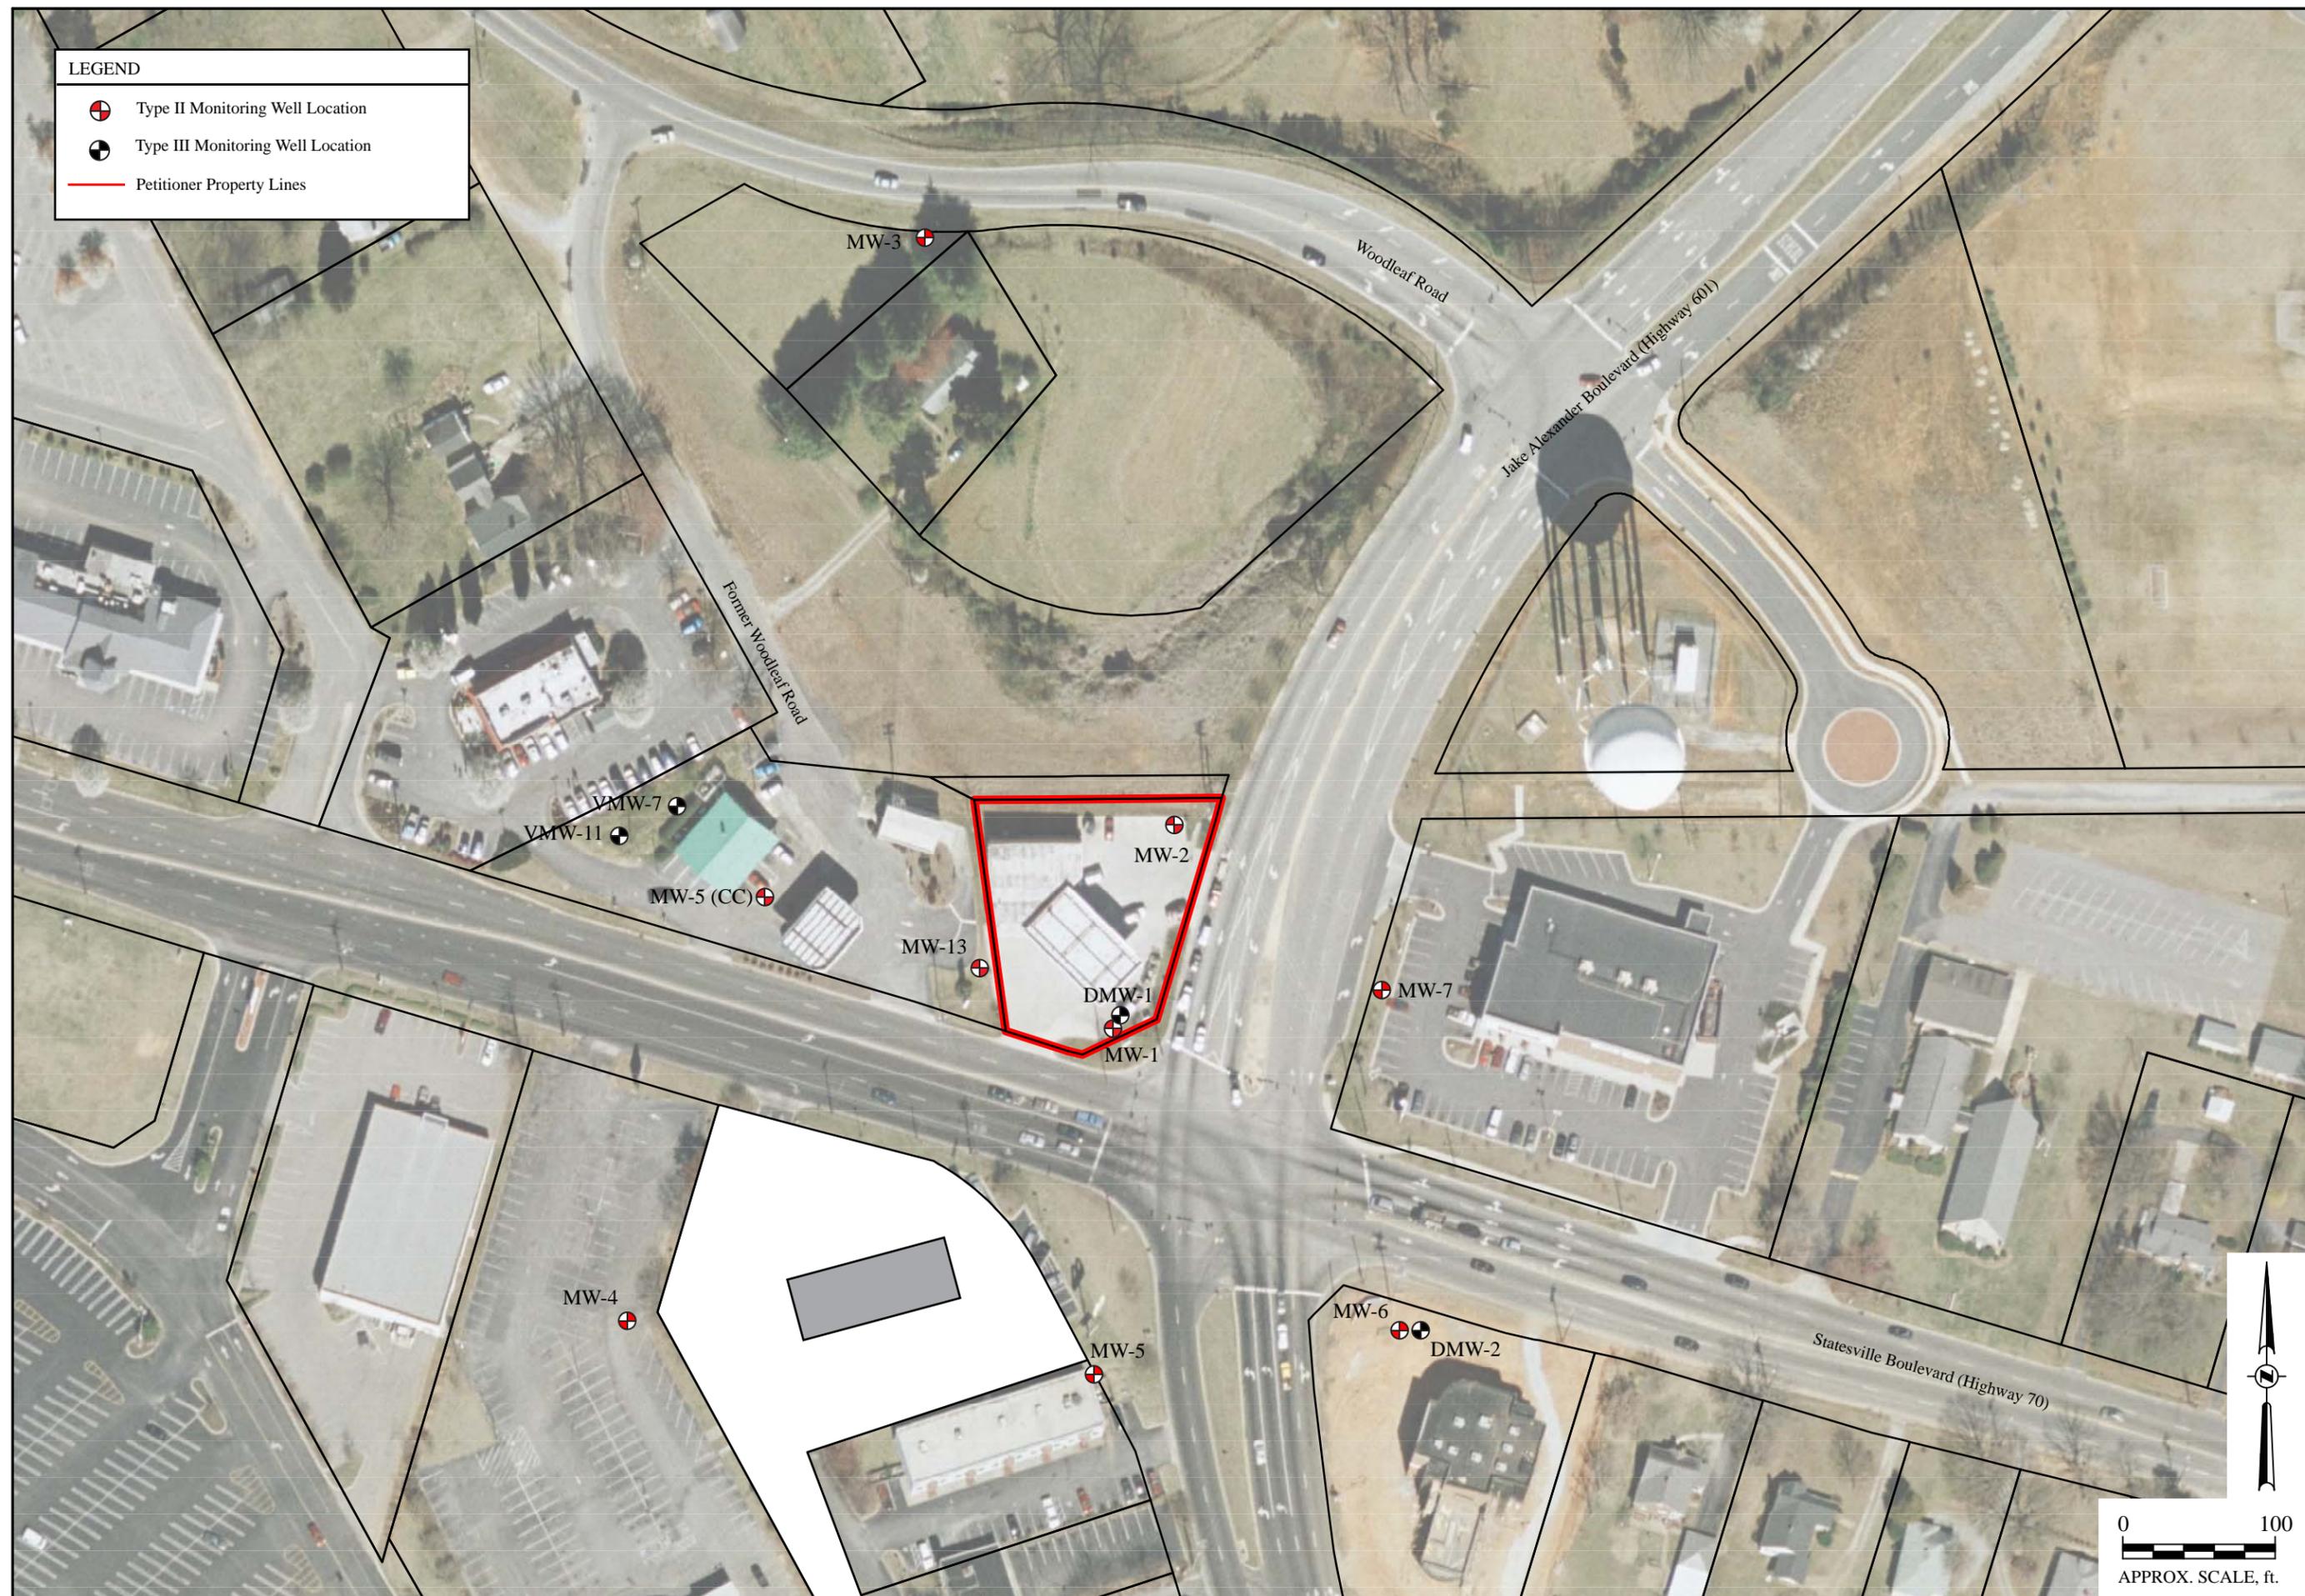
Monitoring Well Location Map  
 Highlander Center Laundry  
 2000 Statesville Boulevard  
 Salisbury, Rowan County, NC  
 DSCA Site #80-0006

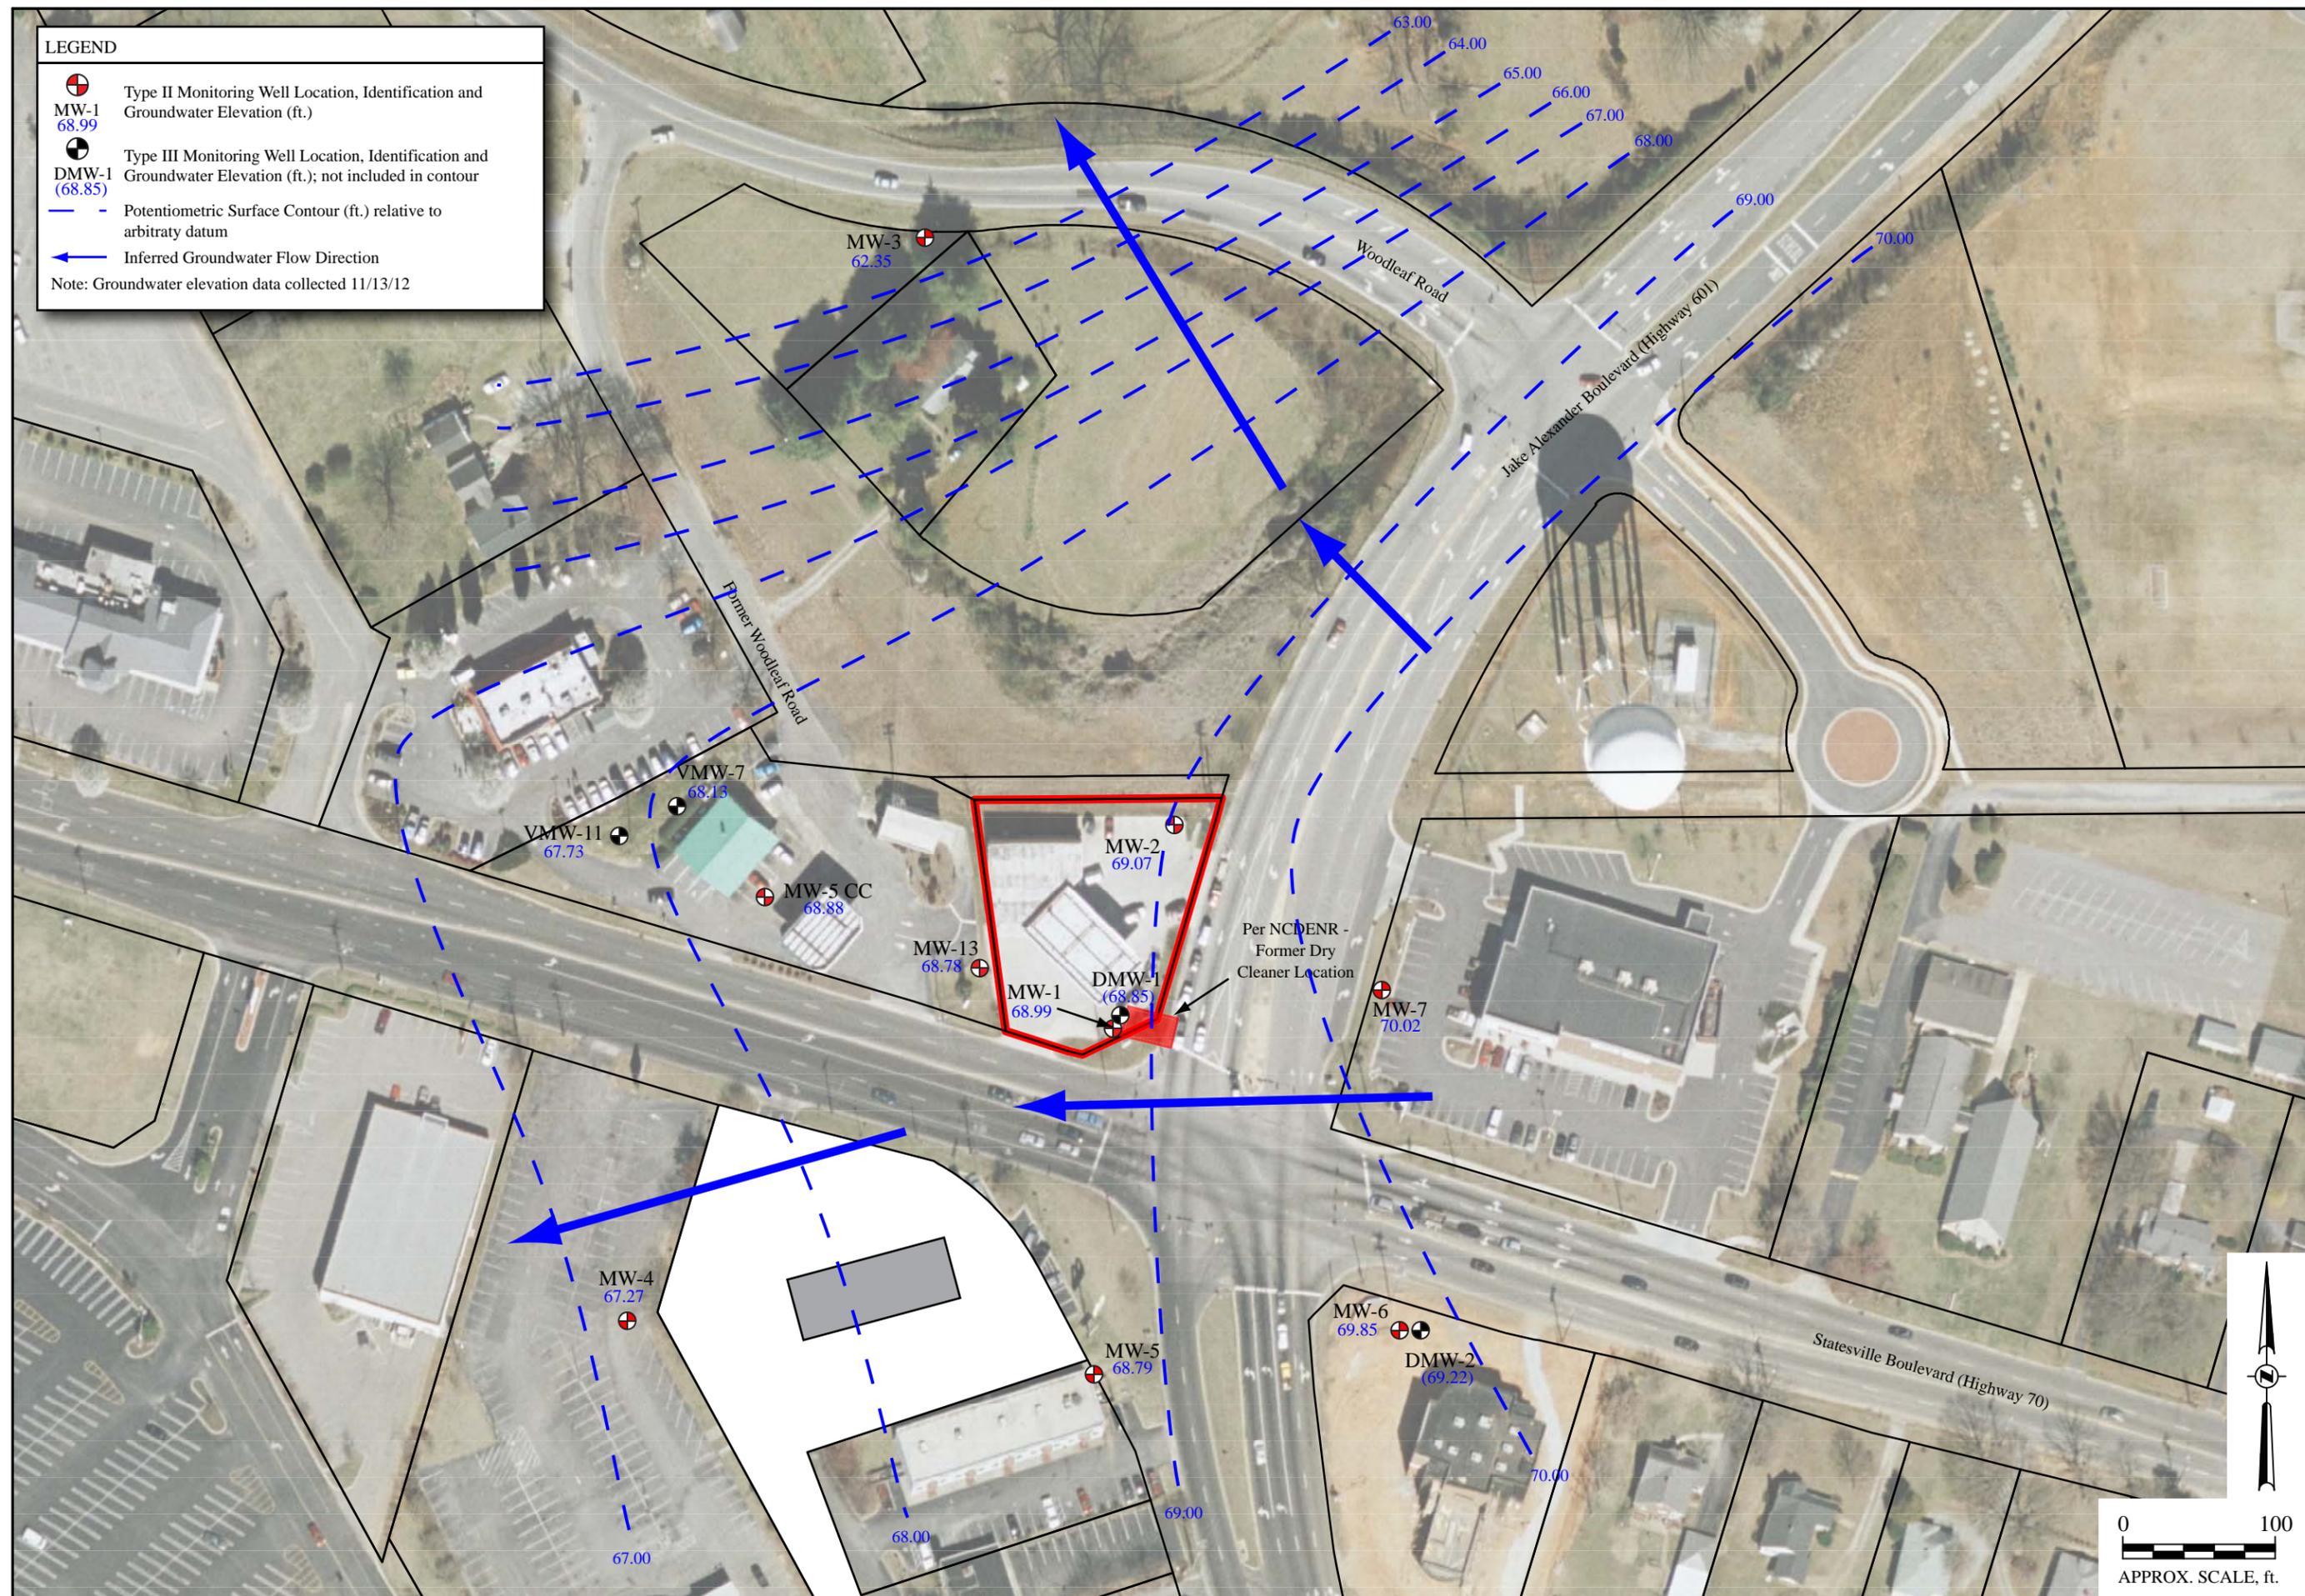
Note: Groundwater elevation data collected 11/13/12

Potentiometric Surface Contour Map  
 Highlander Center Laundry  
 2000 Statesville Boulevard  
 Salisbury, Rowan County, NC  
 DSCA Site #80-0006

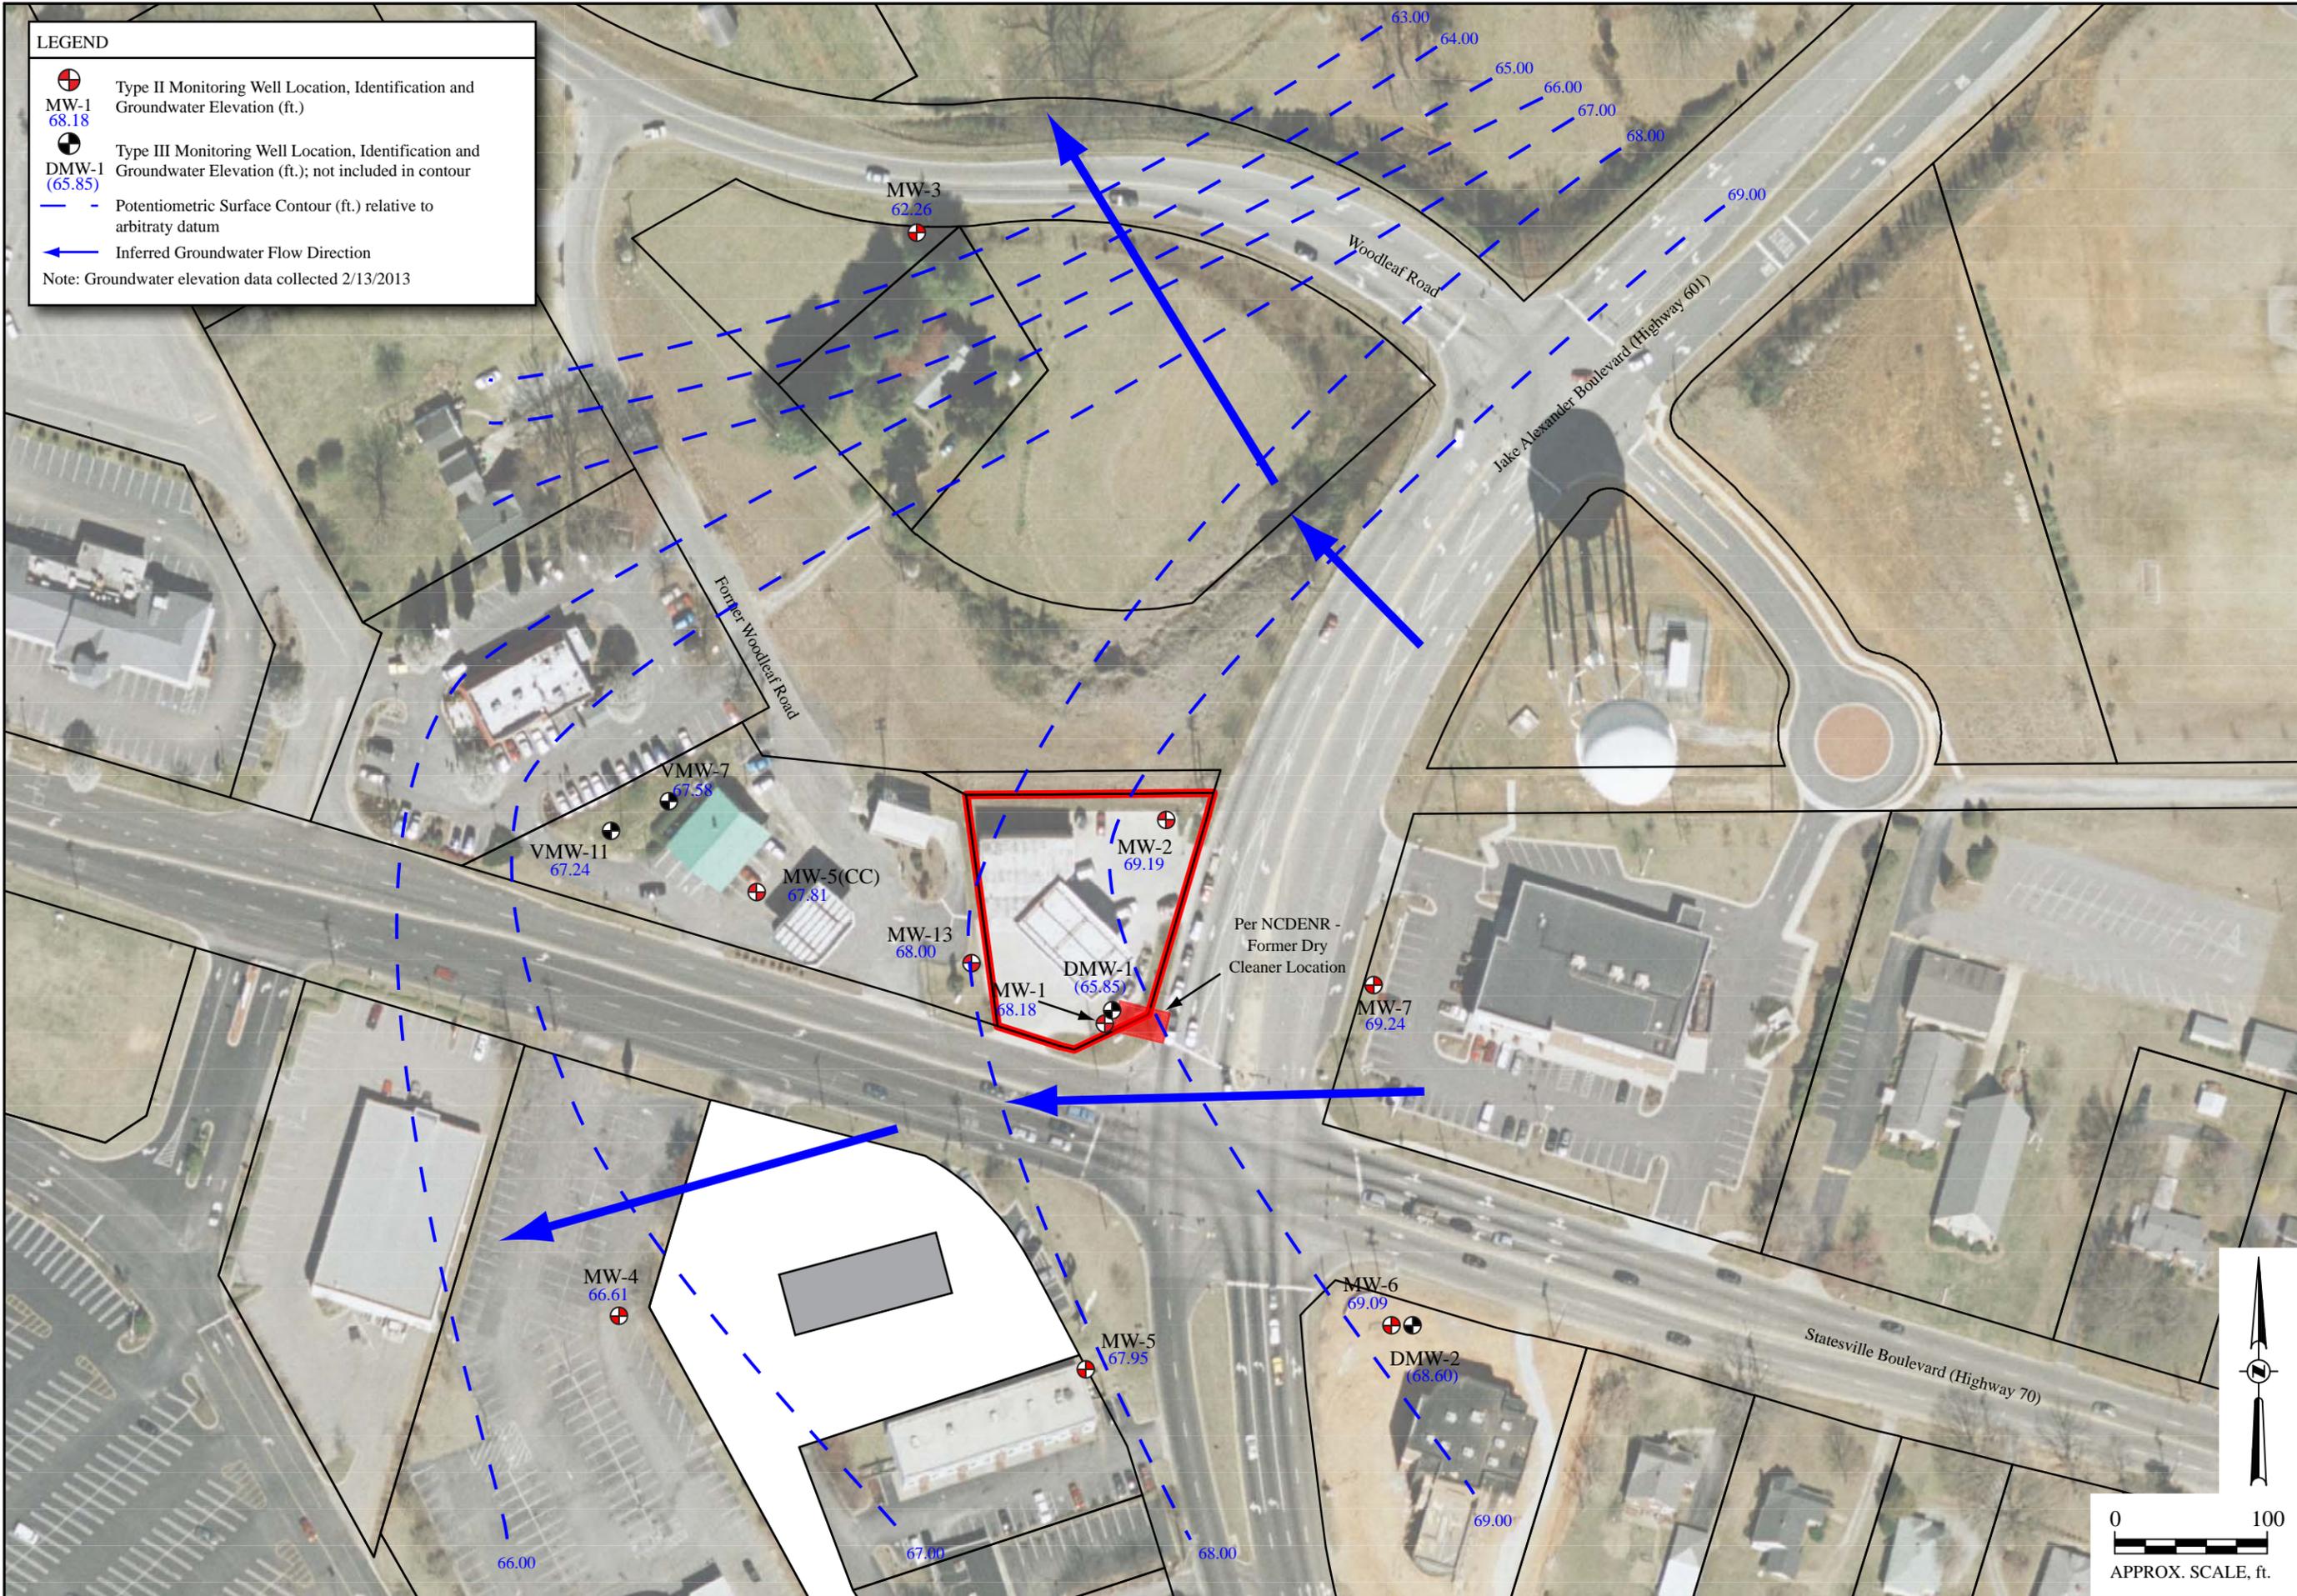
Note: Groundwater elevation data collected 2/13/2013

Potentiometric Surface Contour Map  
 Highlander Center Laundry  
 2000 Statesville Boulevard  
 Salisbury, Rowan County, NC  
 DSCA Site #80-0006

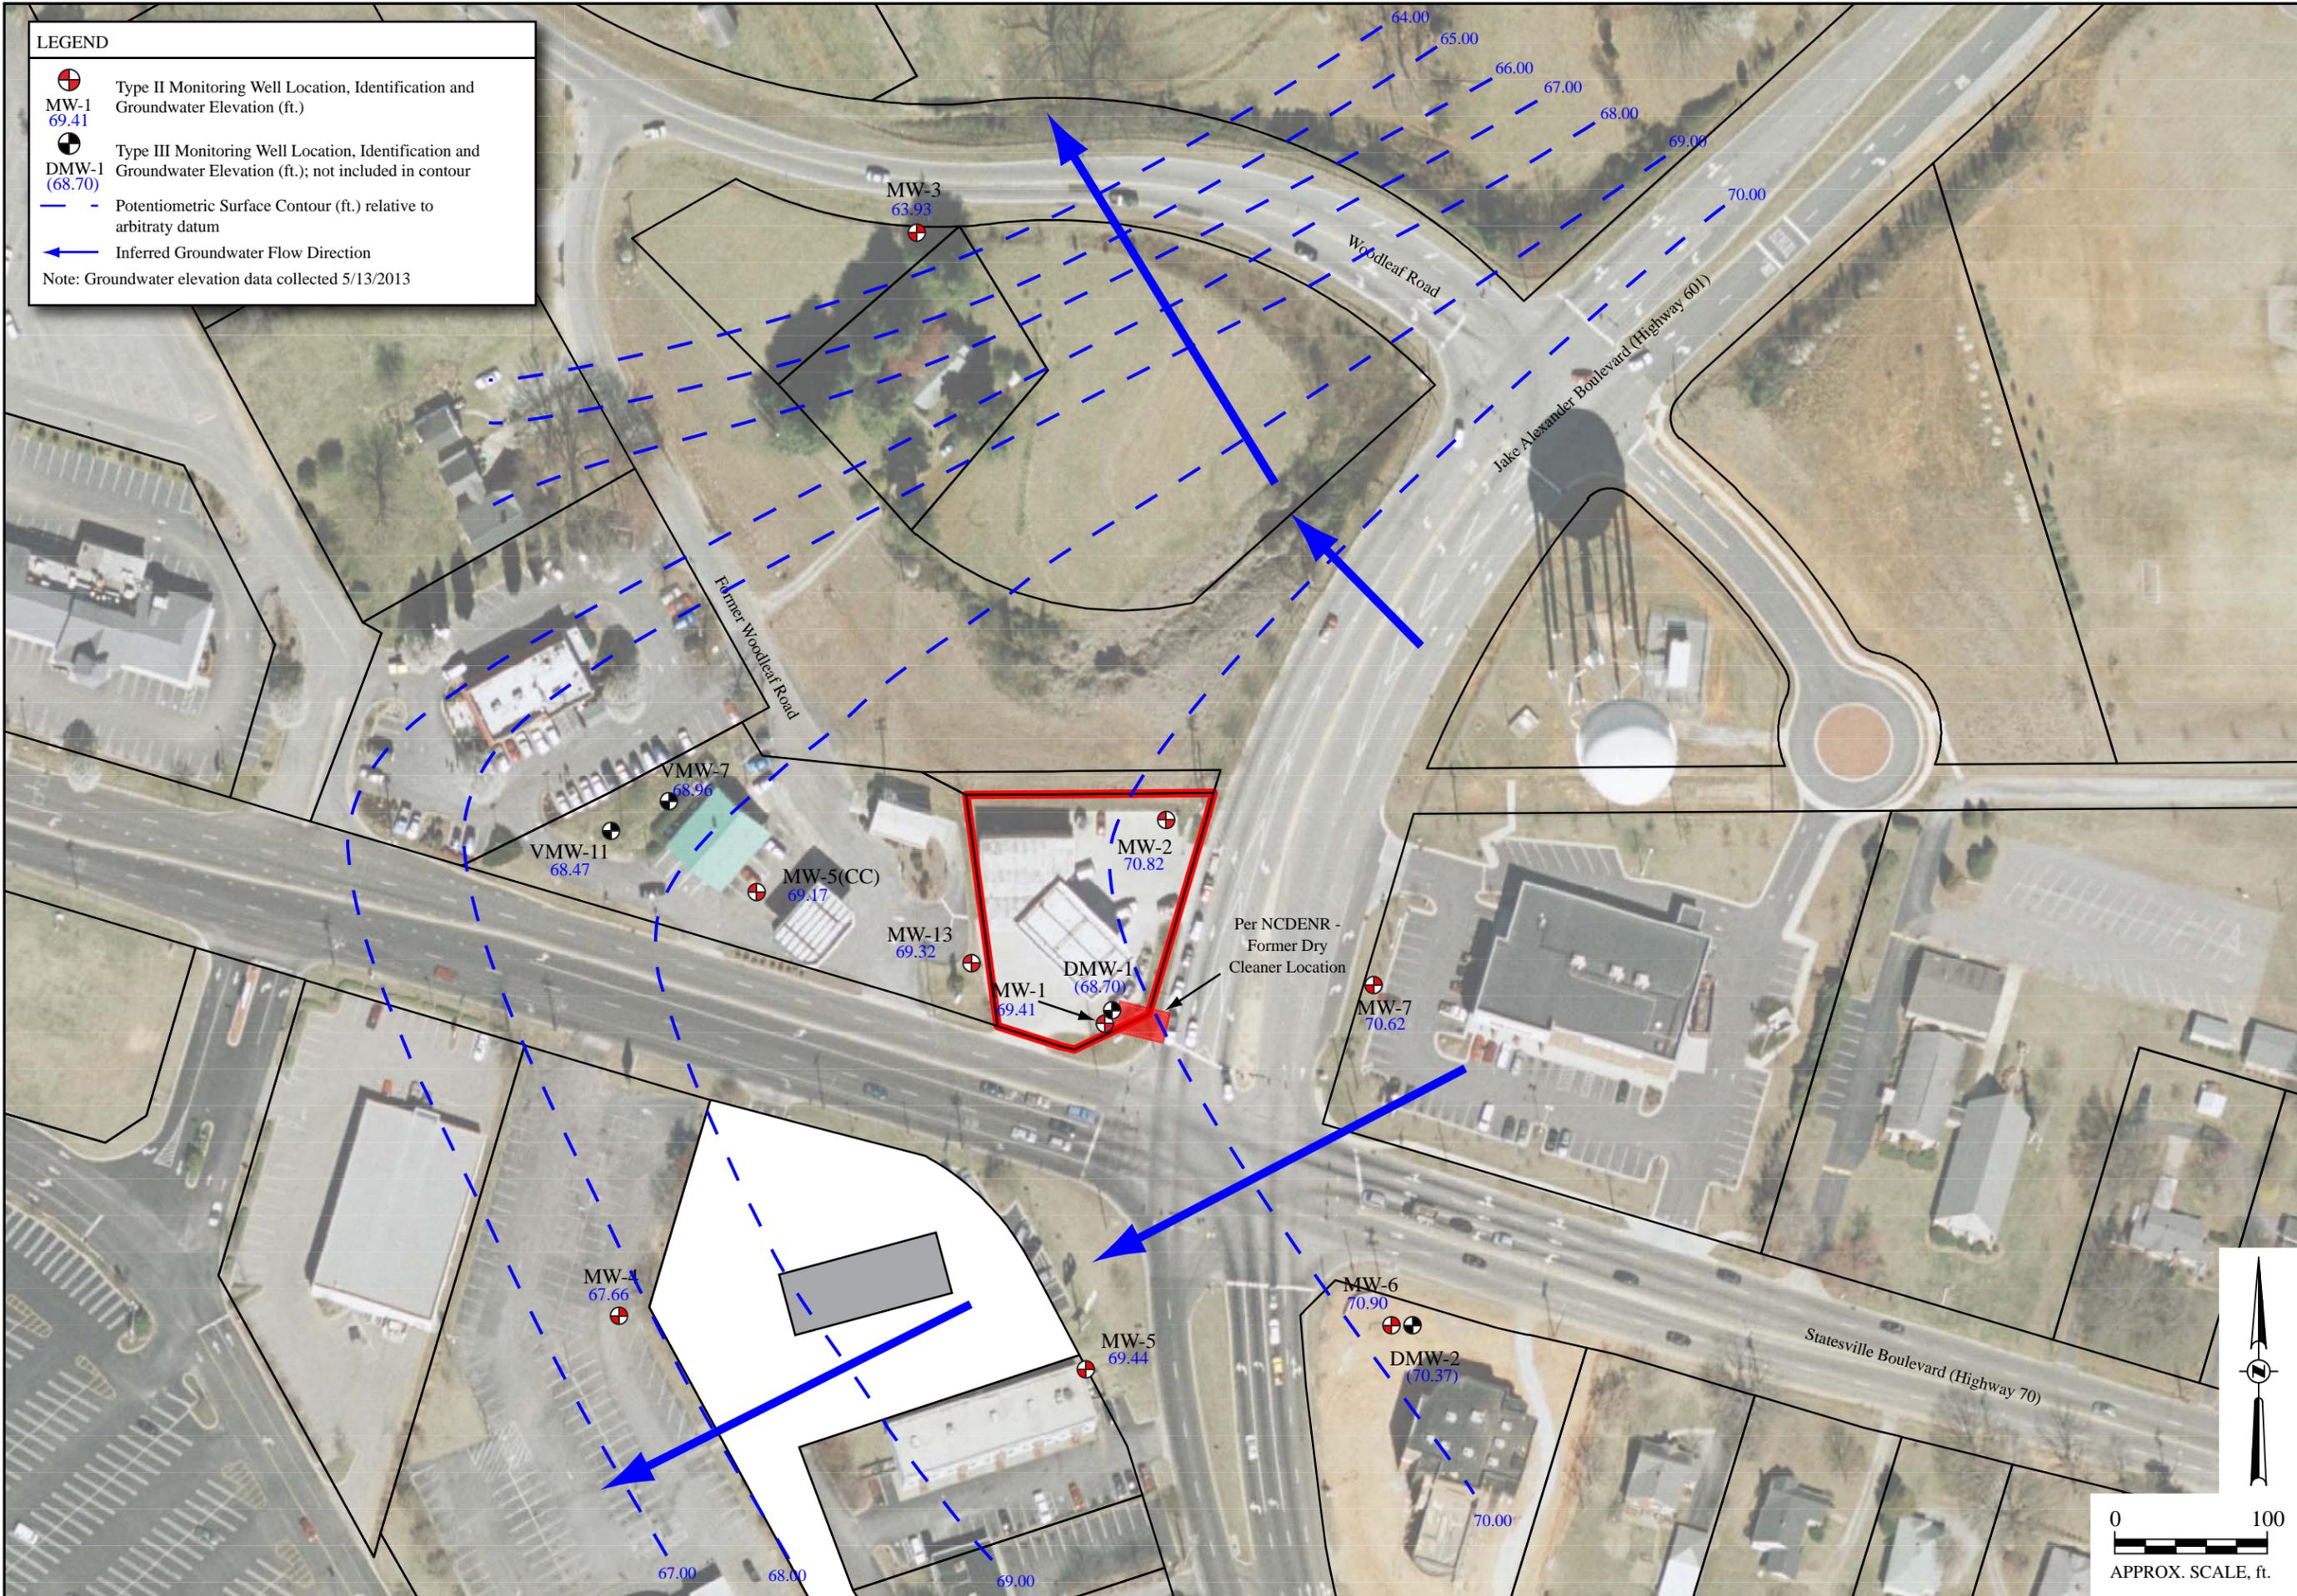
Note: Groundwater elevation data collected 5/13/2013

Potentiometric Surface Contour Map  
 Highlander Center Laundry  
 2000 Statesville Boulevard  
 Salisbury, Rowan County, NC  
 DSCA Site #80-0006

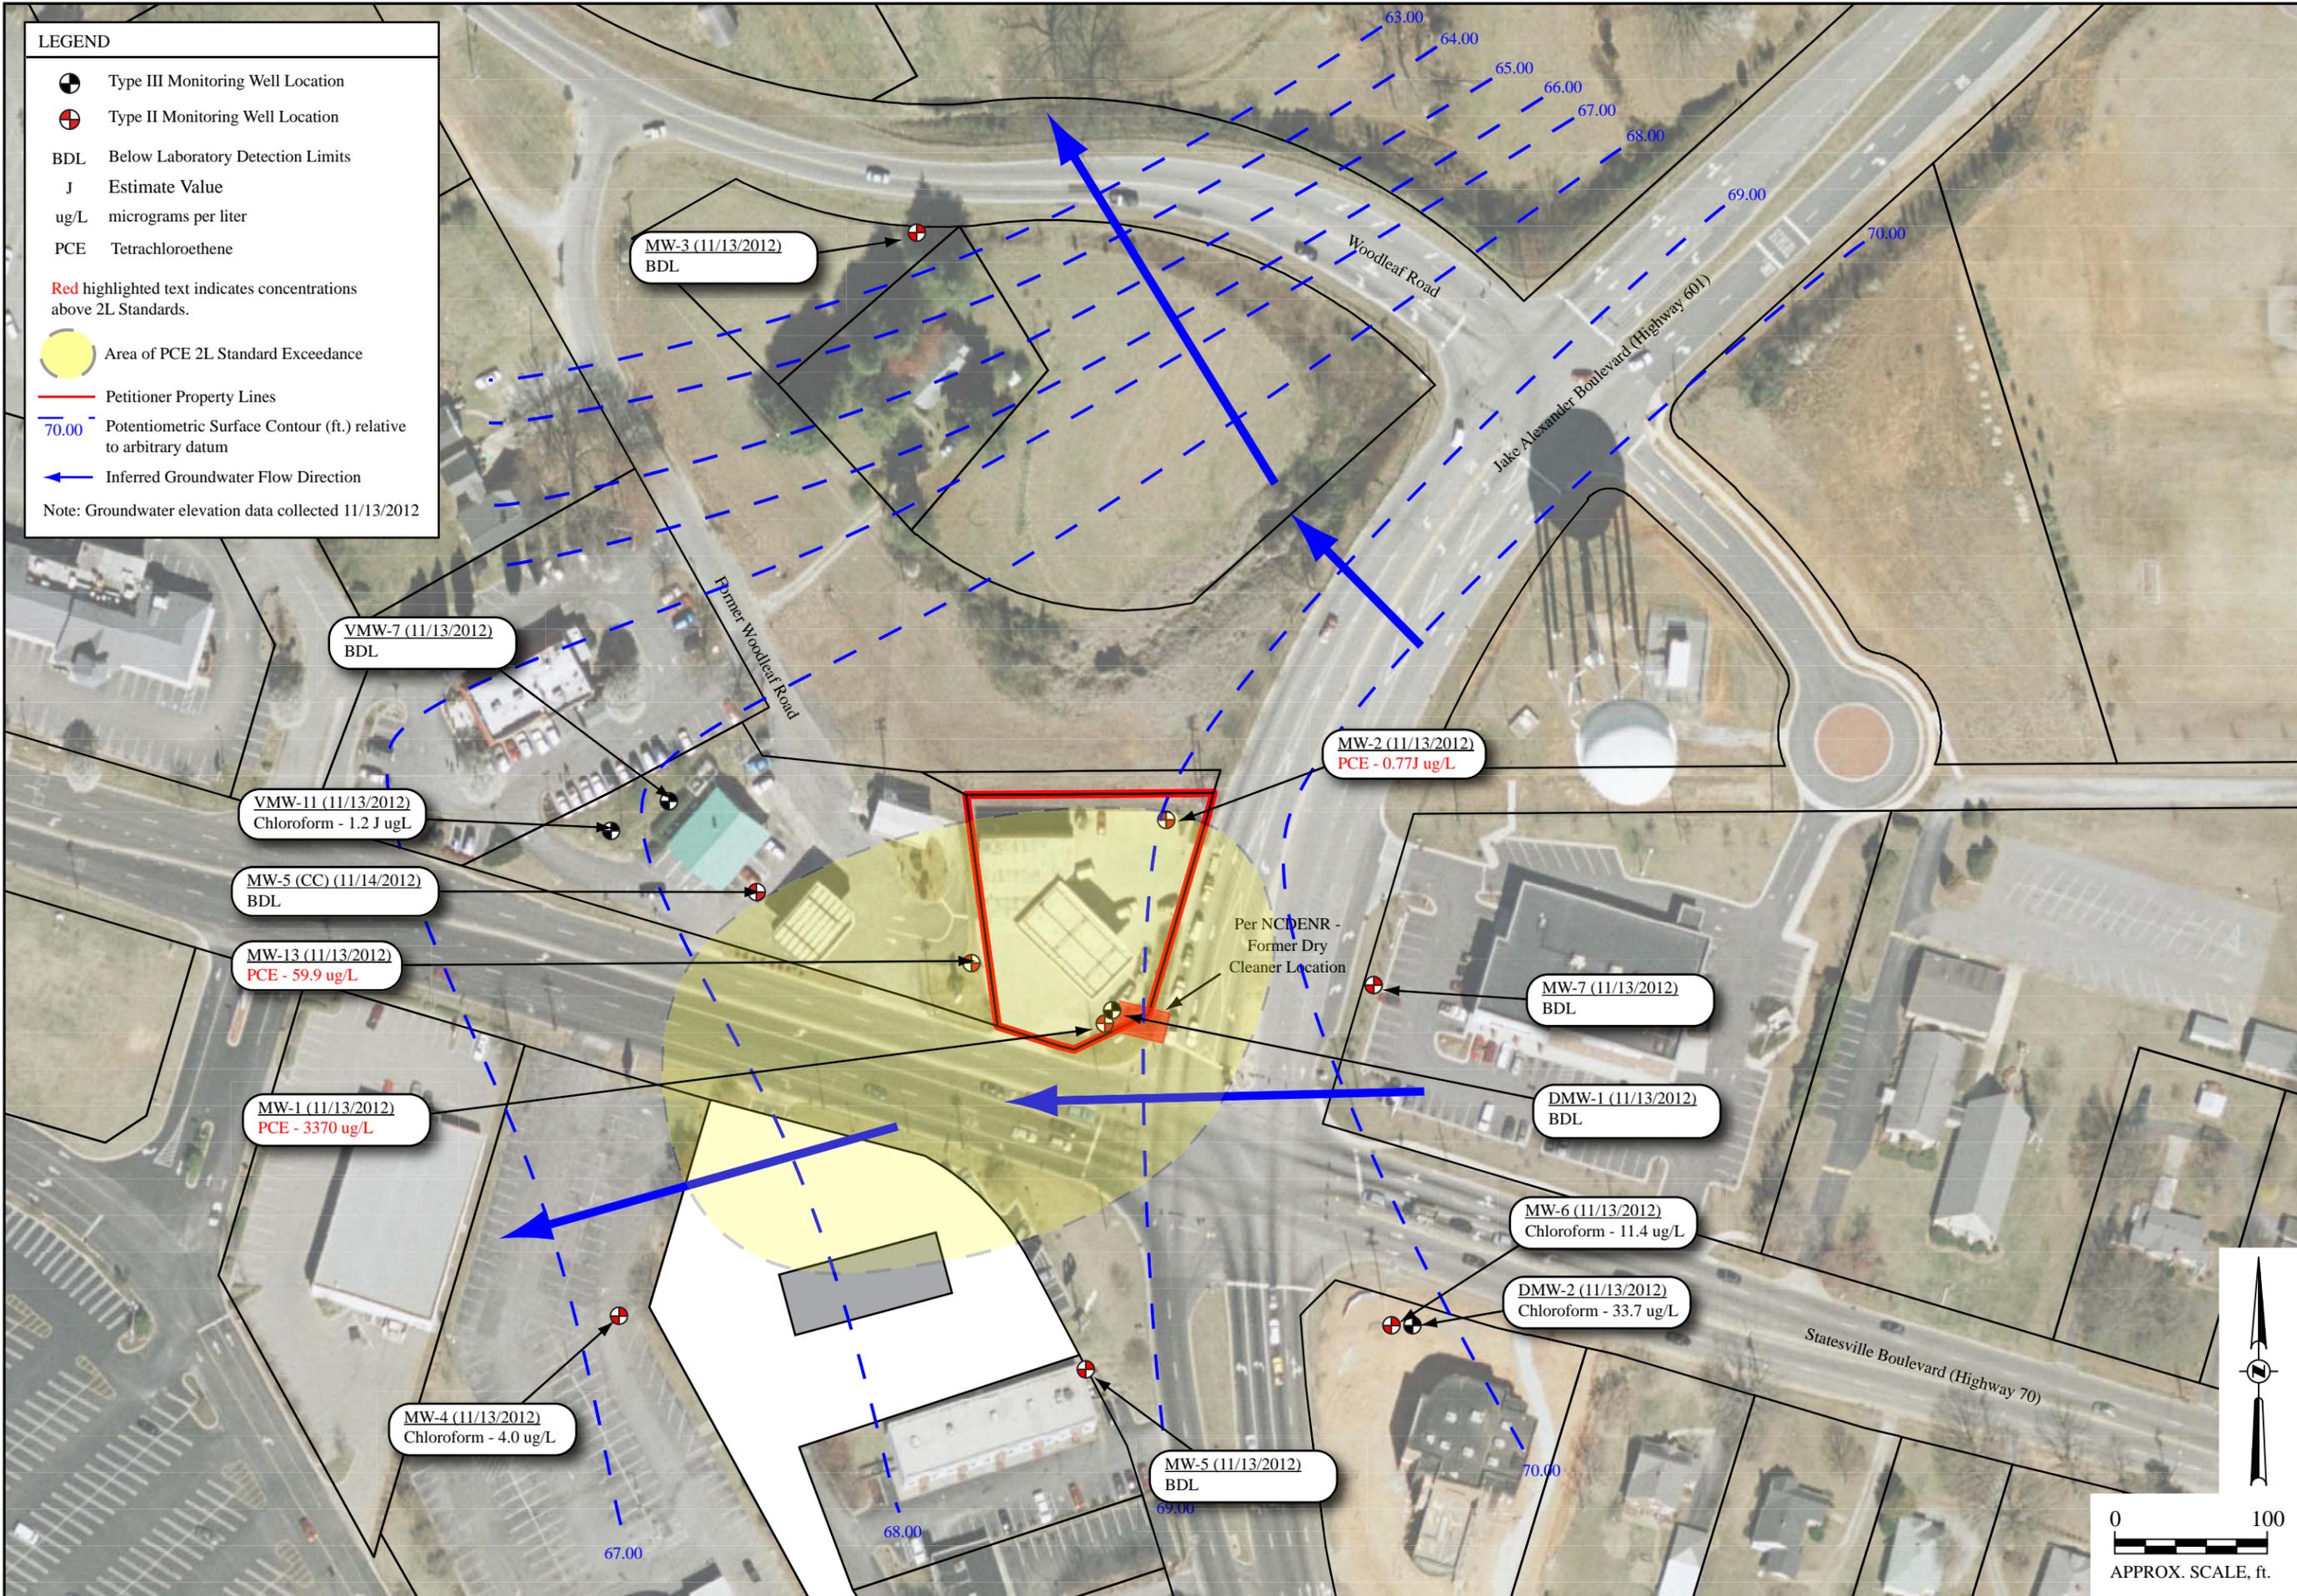
Note: Groundwater elevation data collected 11/13/2012

Chlorinated COC Isoconcentration Map  
 Highlander Center Laundry  
 2000 Statesville Boulevard  
 Salisbury, Rowan County, NC  
 DSCA Site #80-0006
