**REPORT OF PHASE I  
ENVIRONMENTAL SITE ASSESSMENT  
SALISBURY MALL SITE  
SALISBURY, NORTH CAROLINA  
ESP PROJECT NO. E6-BW06.600**

Reference: **REPORT OF PHASE I ENVIRONMENTAL SITE ASSESSMENT**  
**Salisbury Mall Site**  
Salisbury, North Carolina  
ESP Project No. E6-BW06.600

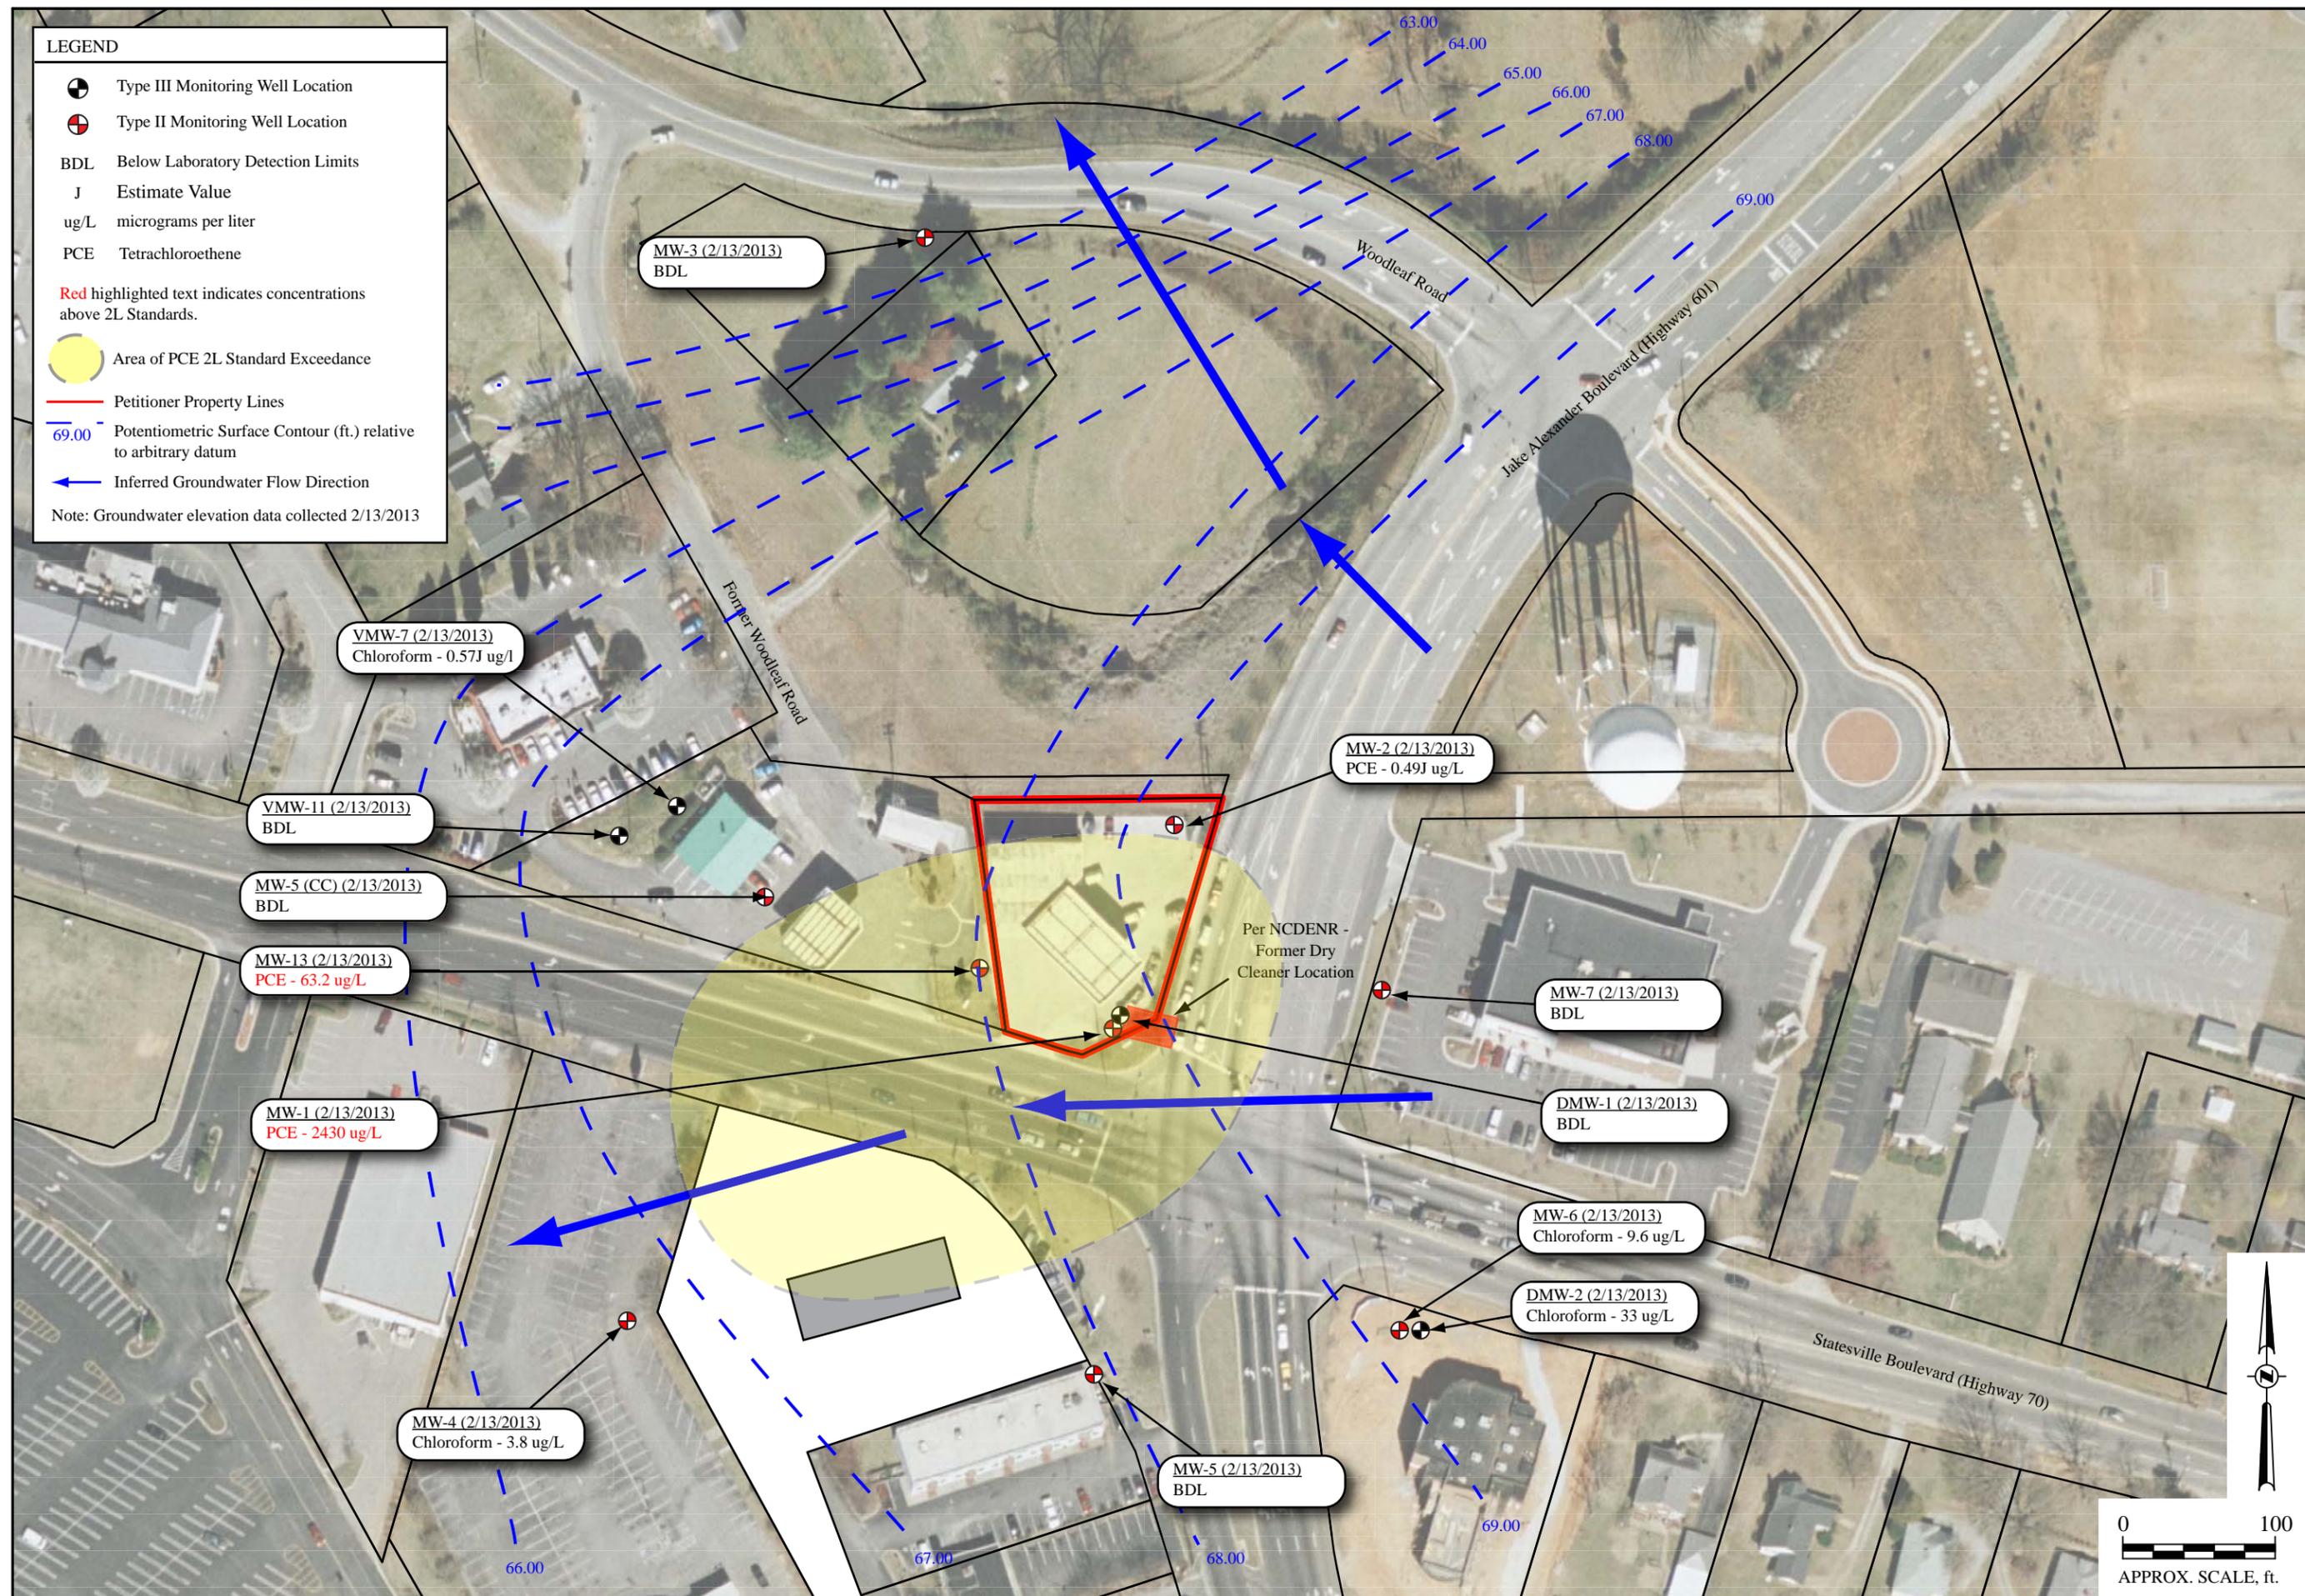
Inferred Groundwater Flow Direction
- Note: Groundwater elevation data collected 2/13/2013

Chlorinated COC Isoconcentration Map  
 Highlander Center Laundry  
 2000 Statesville Boulevard  
 Salisbury, Rowan County, NC  
 DSCA Site #80-0006

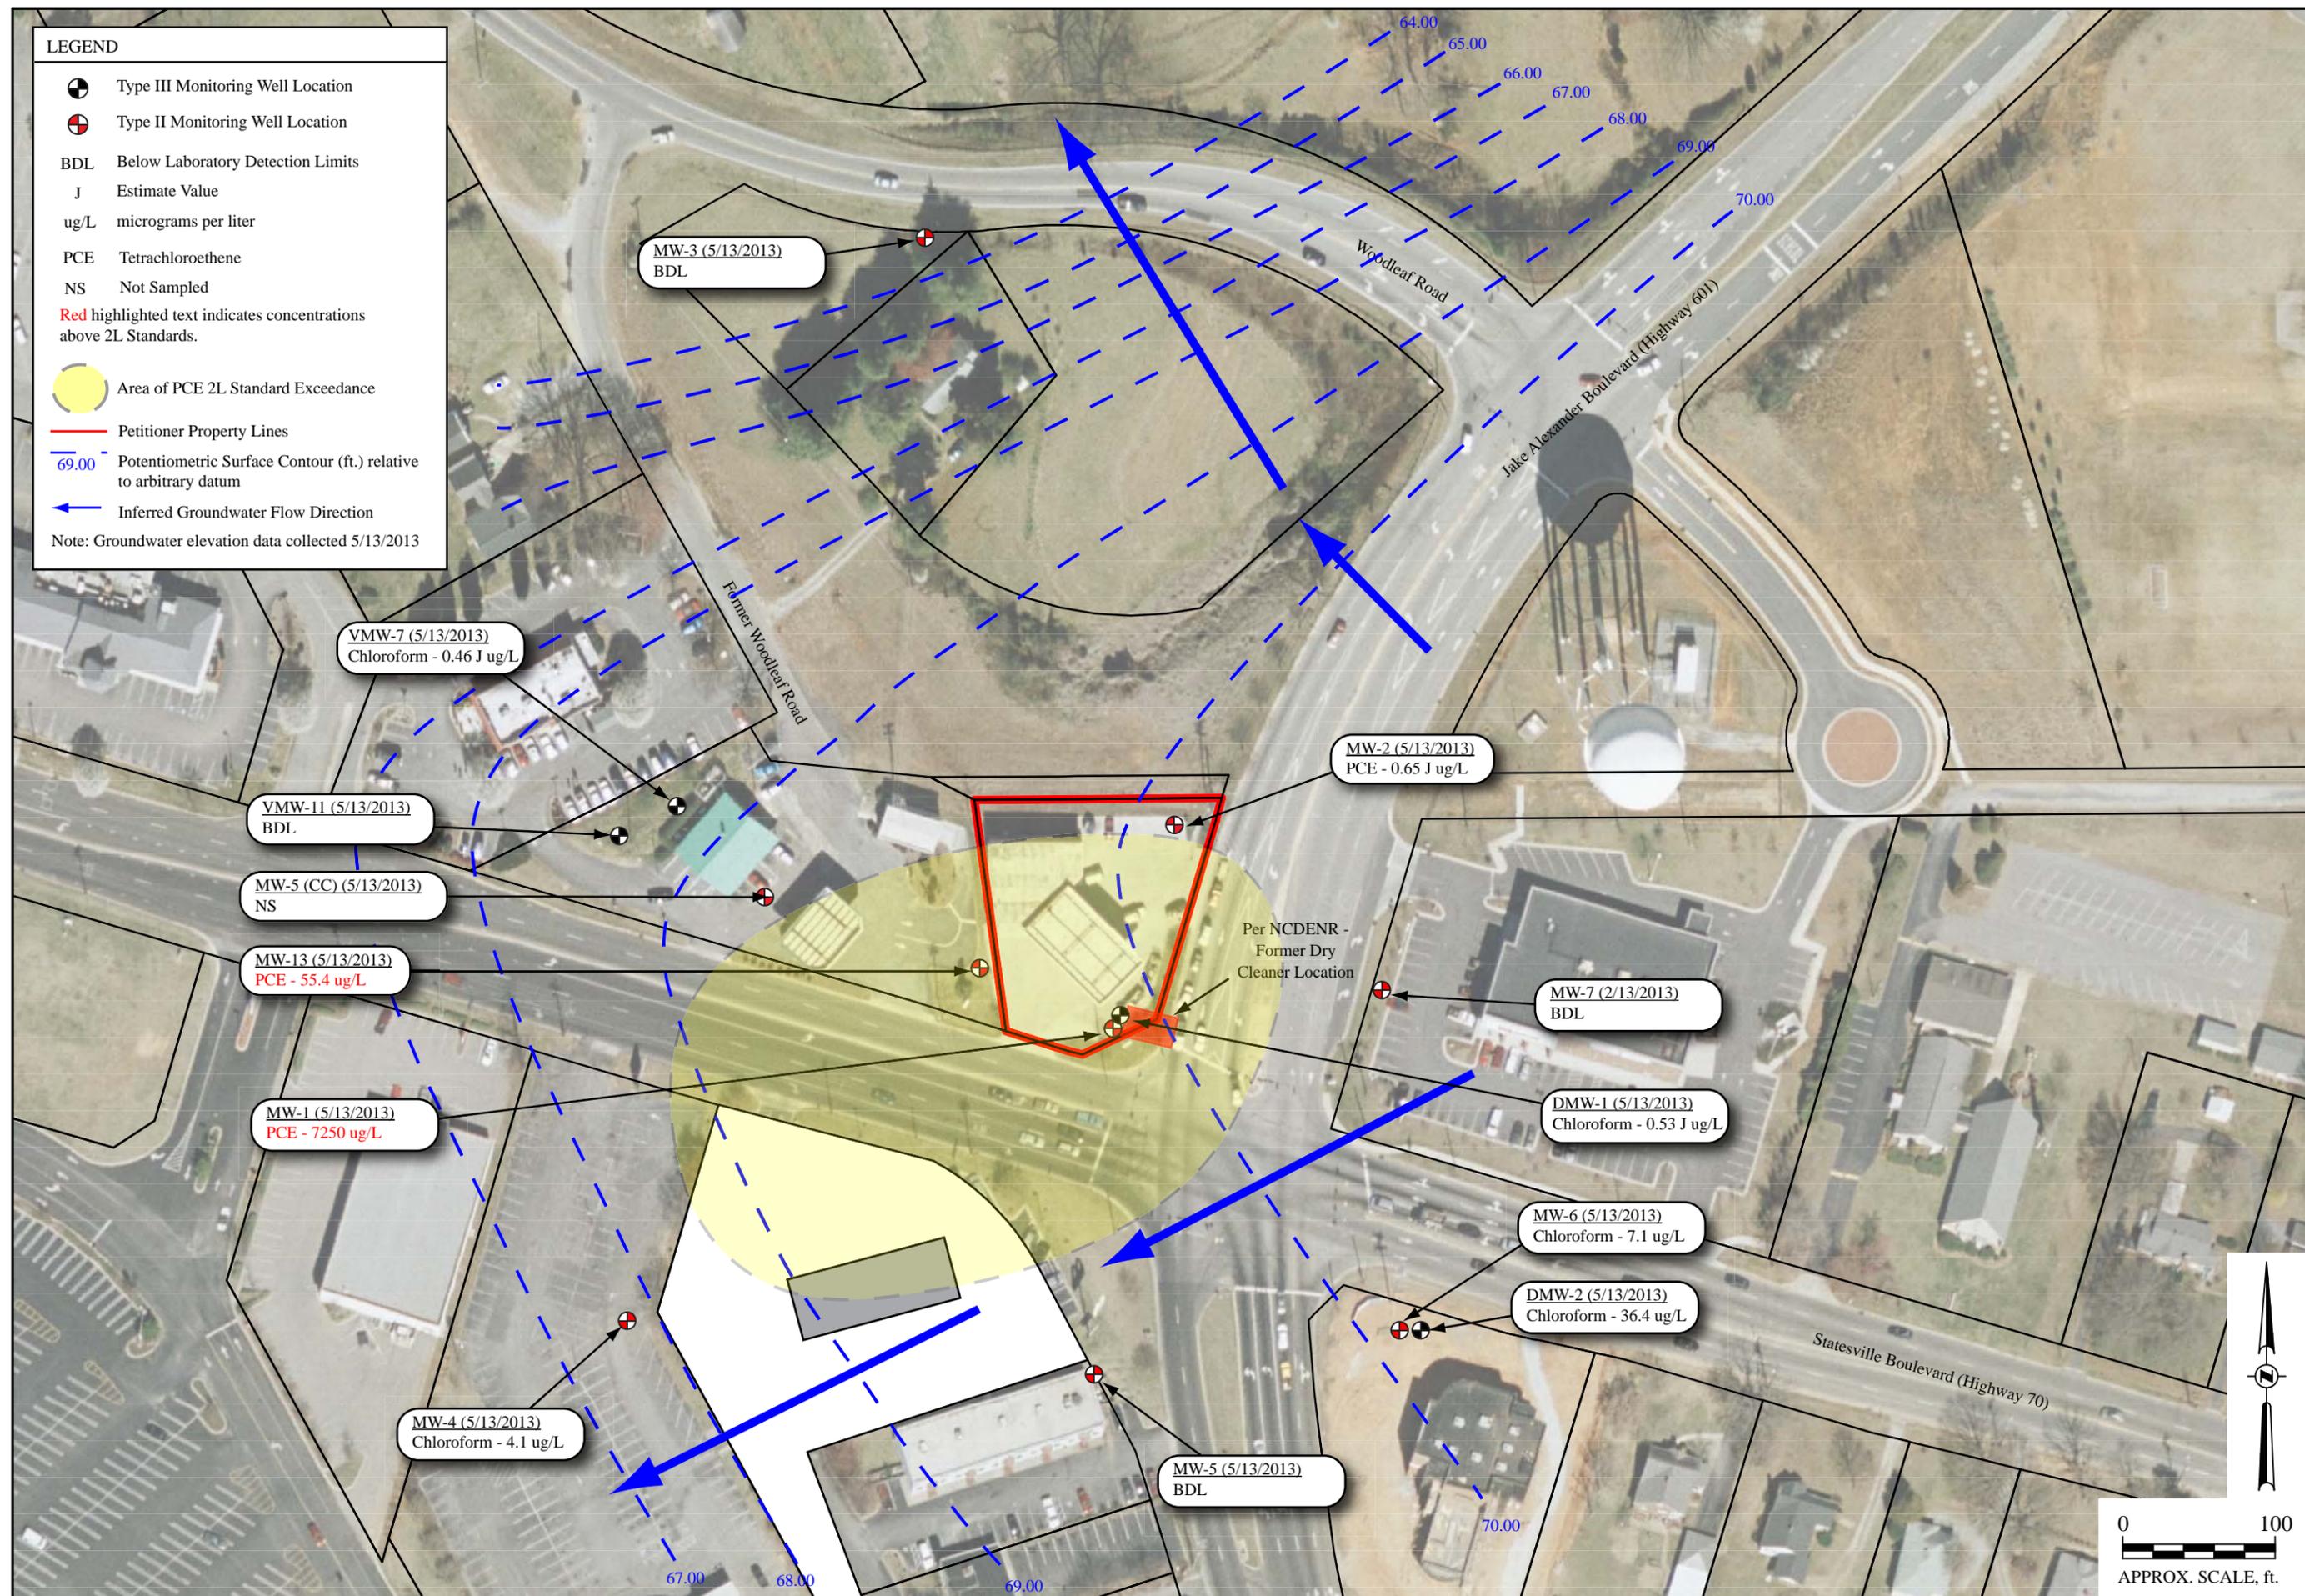
Inferred Groundwater Flow Direction
- Note: Groundwater elevation data collected 5/13/2013

Chlorinated COC Isoconcentration Map  
 Highlander Center Laundry  
 2000 Statesville Boulevard  
 Salisbury, Rowan County, NC  
 DSCA Site #80-0006
