FACILITIES MASTER PLAN

Rowan County

April 2015

101 West Worthington Avenue
Suite 270
Charlotte, NC 28203
ADW Project Number 14032

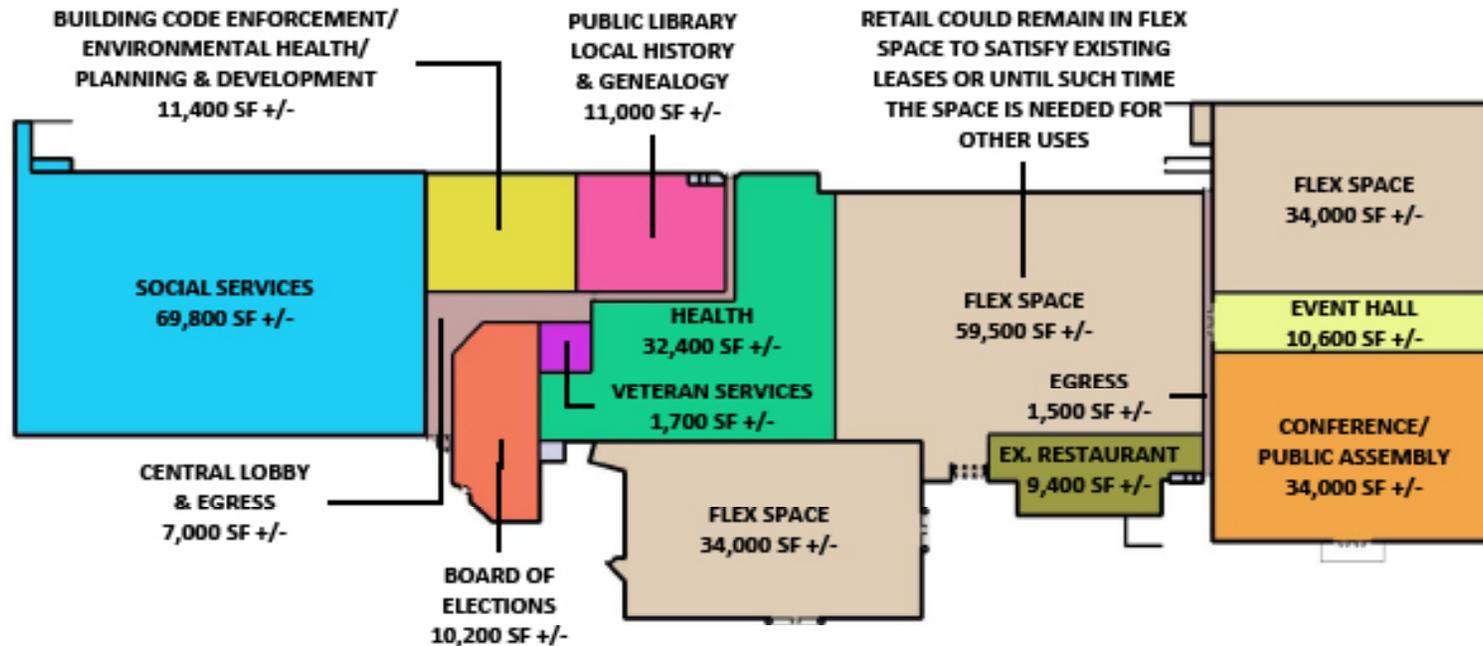
WEST END PLAZA - OPTION A1

15 Year Projected Growth

- 63,000sf – Social Services
- 30,000sf – Health
- 10,000sf – Board of Elections
- 10,000sf – Public Library – Local History & Genealogy
- 4,600sf – Planning & Development
- 3,500sf – Building Code Enforcement
- 2,400sf – Environmental Health
- 1,600sf – Veteran Services

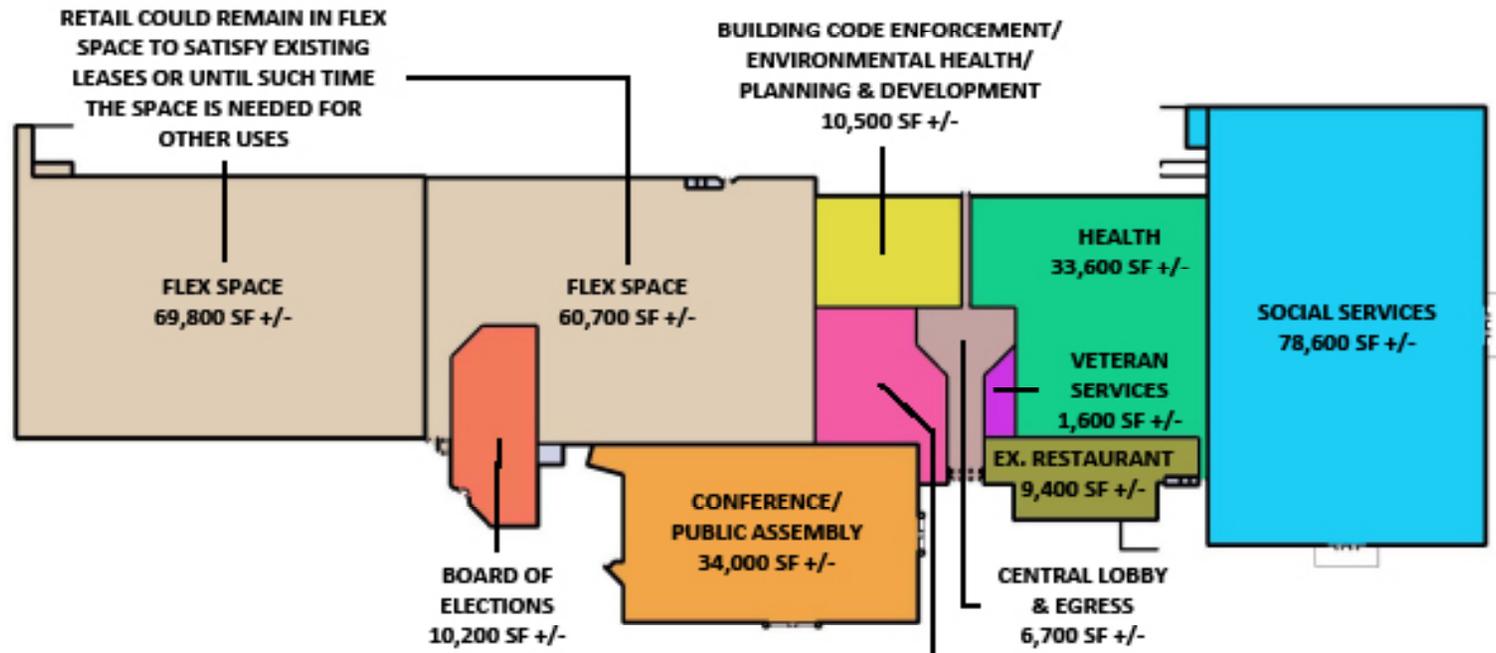
WEST END PLAZA - OPTION A2

15 Year Projected Growth

- 63,000sf – Social Services
- 30,000sf – Health
- 10,000sf – Board of Elections
- 10,000sf – Public Library – Local History & Genealogy
- 4,600sf – Planning & Development
- 3,500sf – Building Code Enforcement
- 2,400sf – Environmental Health
- 1,600sf – Veteran Services

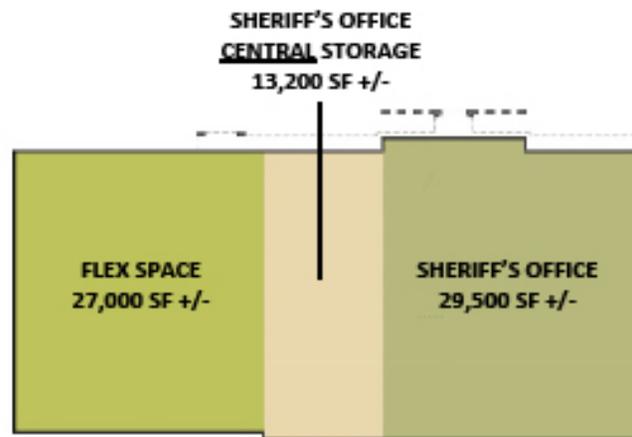
1811/ 1813 EAST INNES STREET

15 Year Projected Growth
29,200sf – Sheriff's Office

Projected Construction Cost
234,000 – Shell Improvements
1,582,000 – Sheriff's Office Upfit

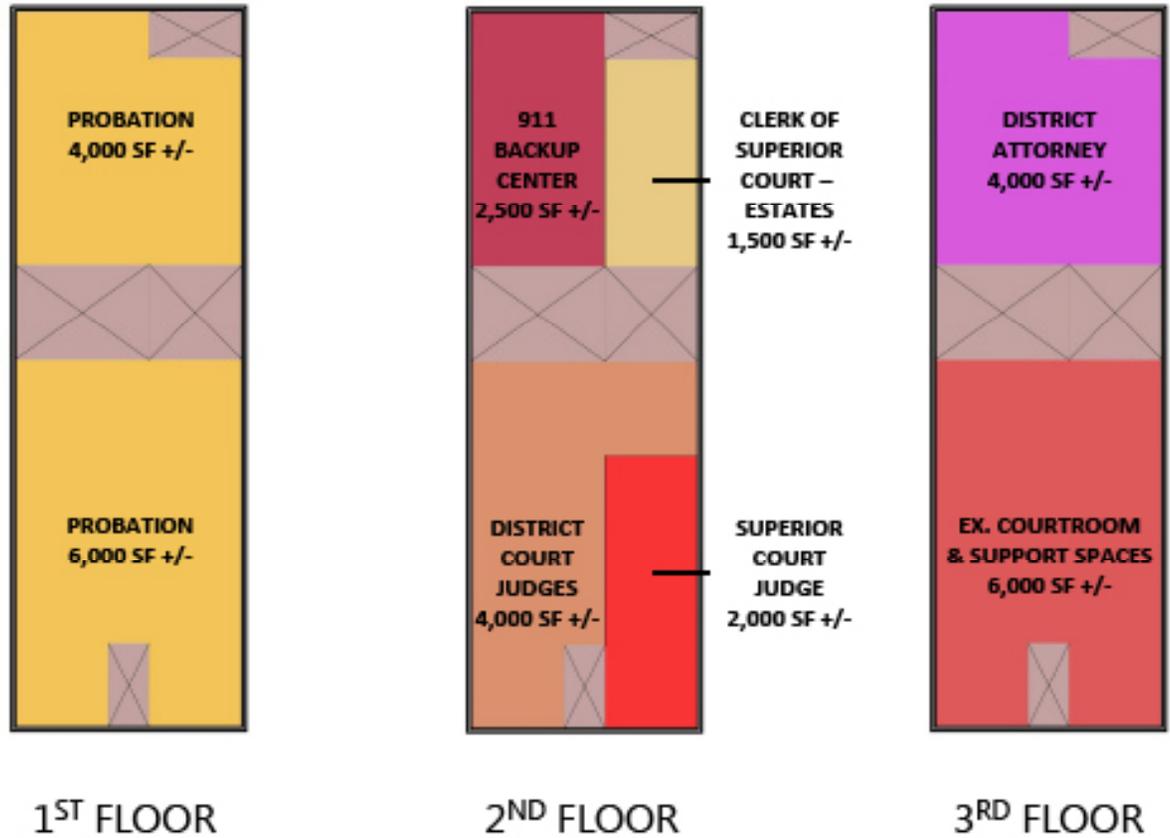
232 NORTH MAIN STREET

1ST FLOOR

2ND FLOOR

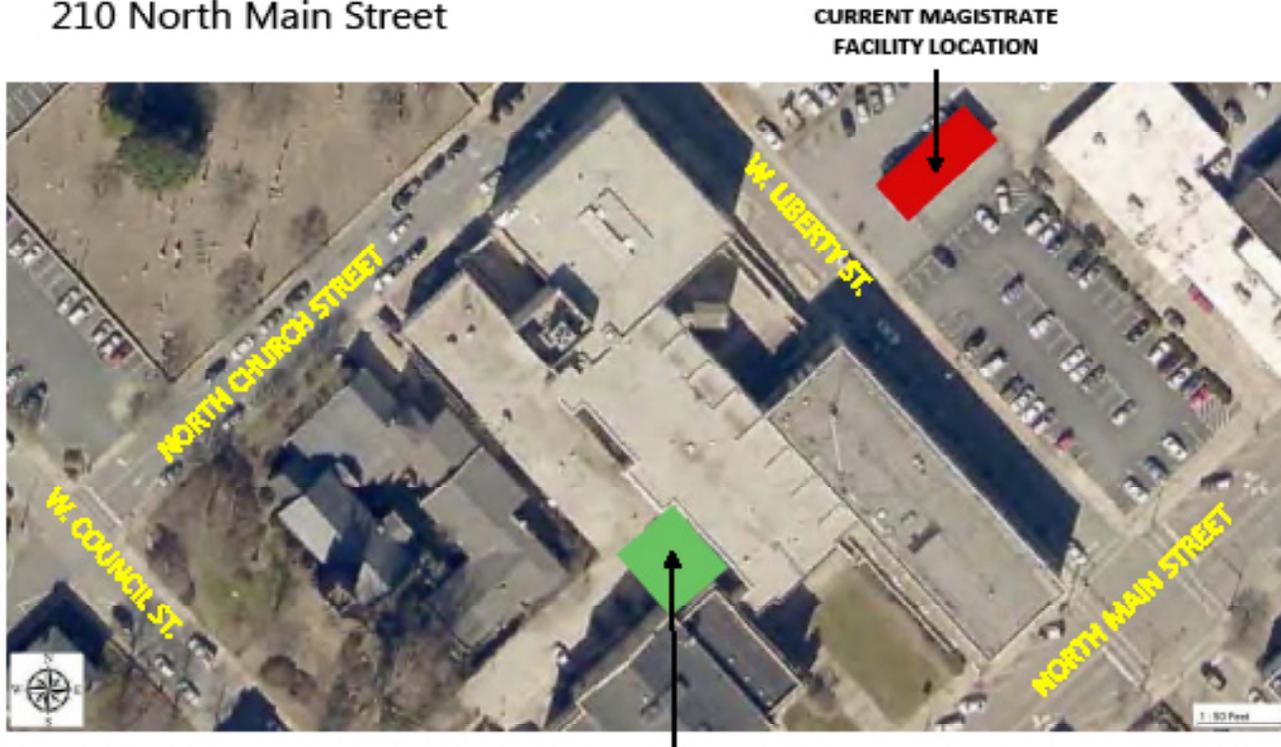
Option 2

- New Magistrate Facility
 - Located behind Clerk of Superior Court
210 North Main Street

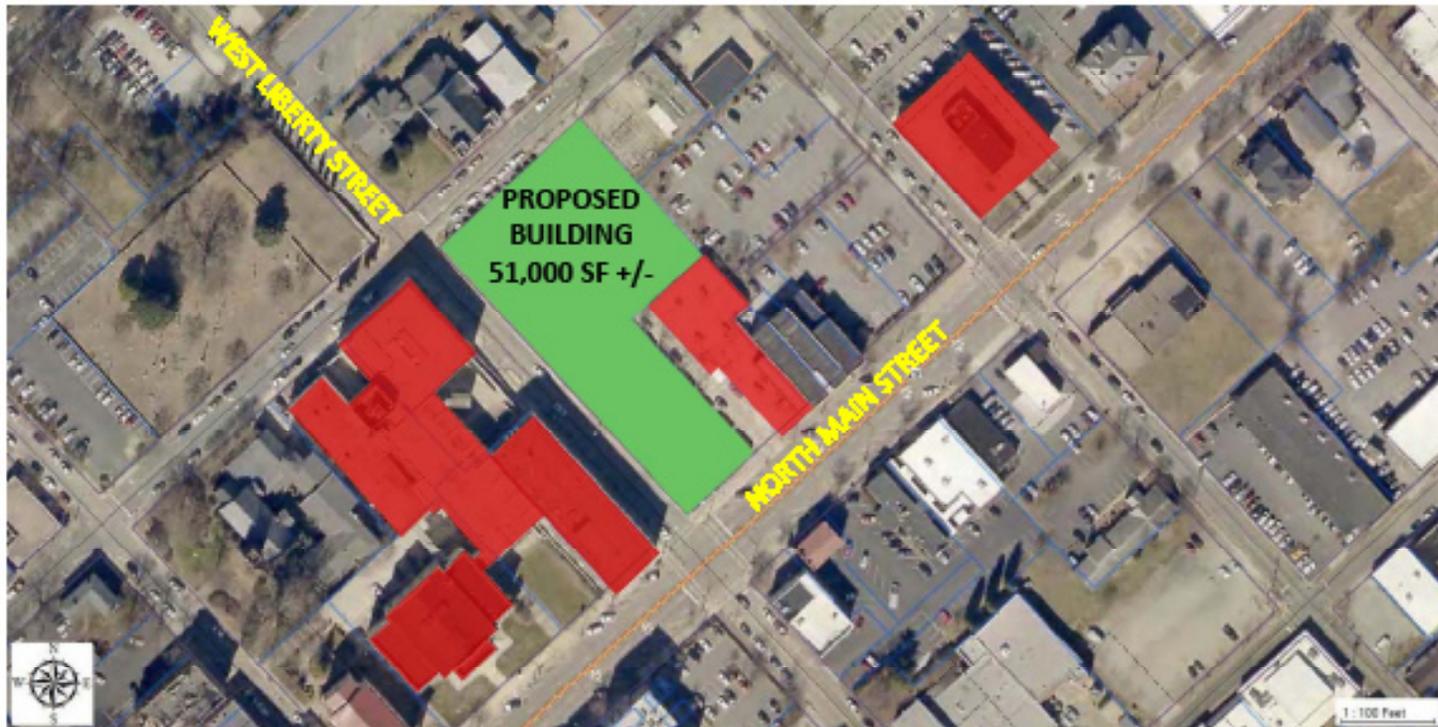
WEST LIBERTY STREET

Departments to be relocated and Facilities in proposed new building:

- Sheriff's Office - 29,200 sf (15-yr projected growth)
- Probation – 19,000 sf (15-yr projected growth)
- Magistrate – 2,800 sf (15-yr projected growth)
- Structured parking and over-street bridge

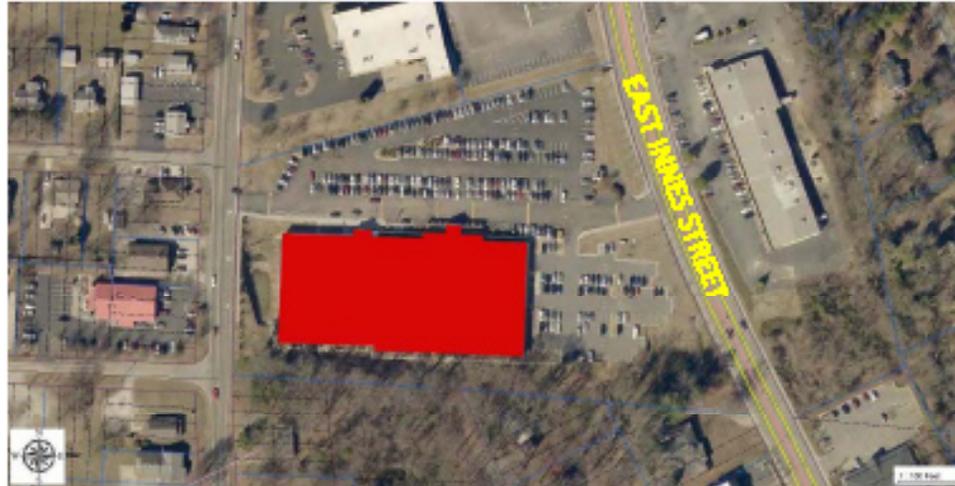
1811/ 1813 EAST INNES STREET

Current Department to be vacated from here:

- Health

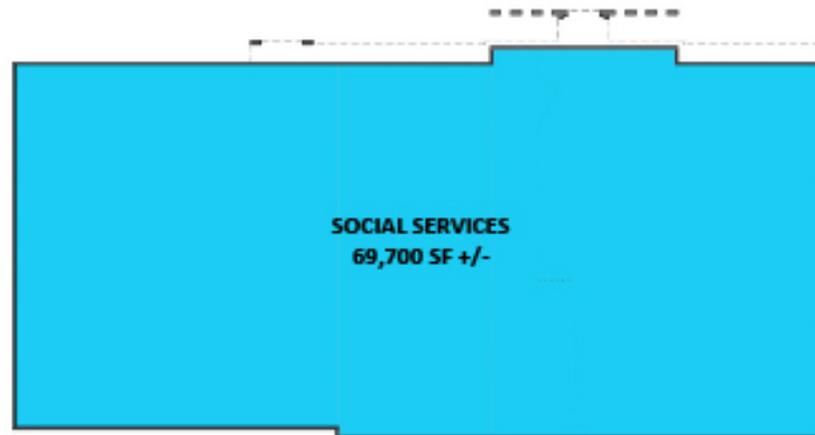
1811/1813 EAST INNES STREET

15 Year Projected Growth
63,000sf – Social Services

Projected Construction Cost
234,000 – Shell Improvements
996,000 – Social Services

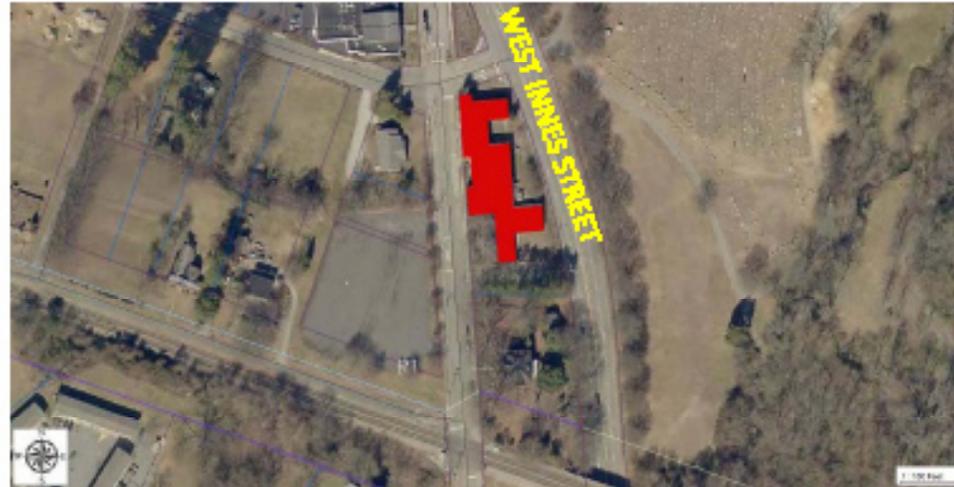
1236 WEST INNES STREET

Departments to be relocated here:

- Health
 - Demolish existing building
 - Construct new 30,000 sf facility
 - Based on 15-yr projected growth

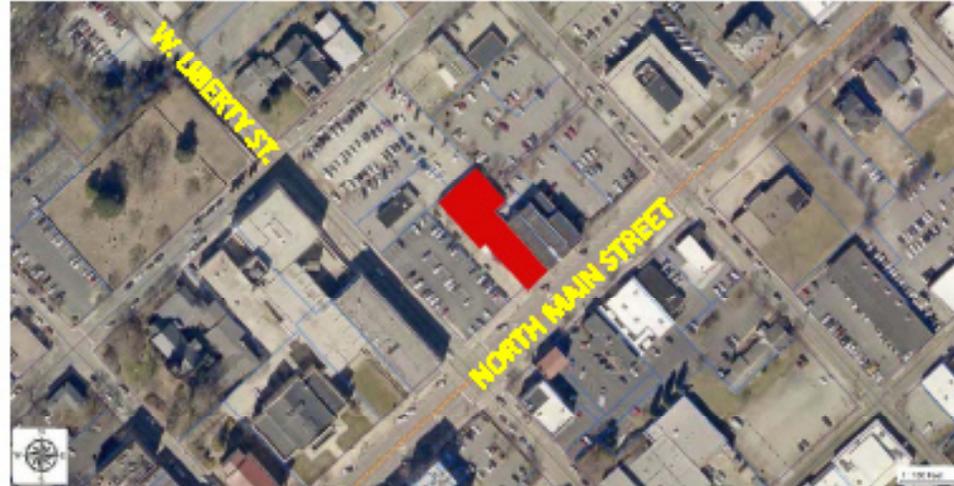
310 NORTH MAIN STREET

Current Departments to remain here:

- None

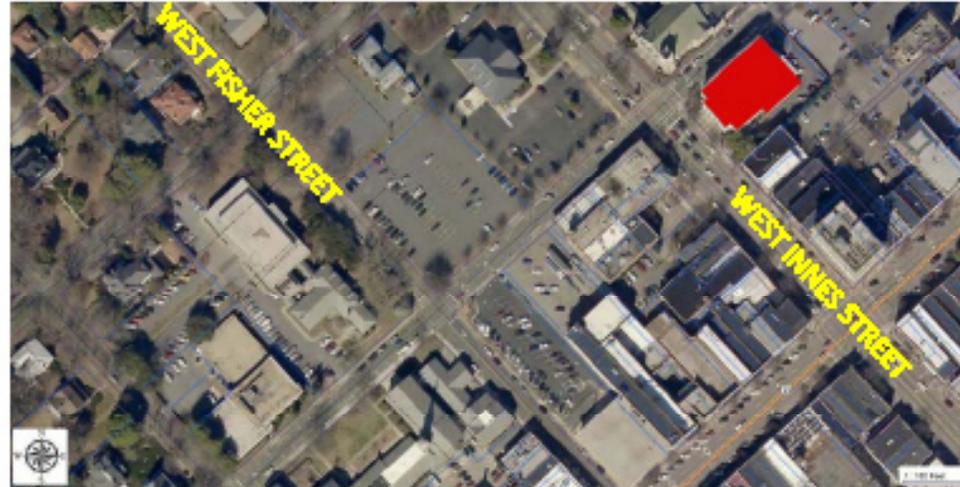
130 WEST INNES STREET – ADMINISTRATION BUILDING

Current Departments to be vacated from here:

- Board of Elections

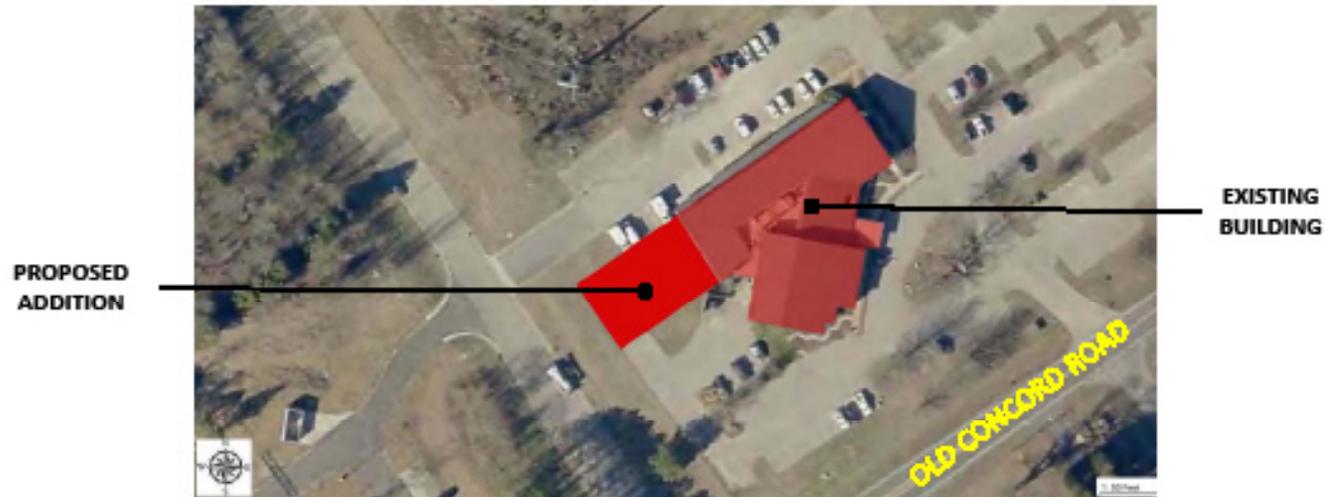
2727 OLD CONCORD ROAD

Current Departments to be expanded here:

- Emergency Services
 - 7,500sf +/- Addition

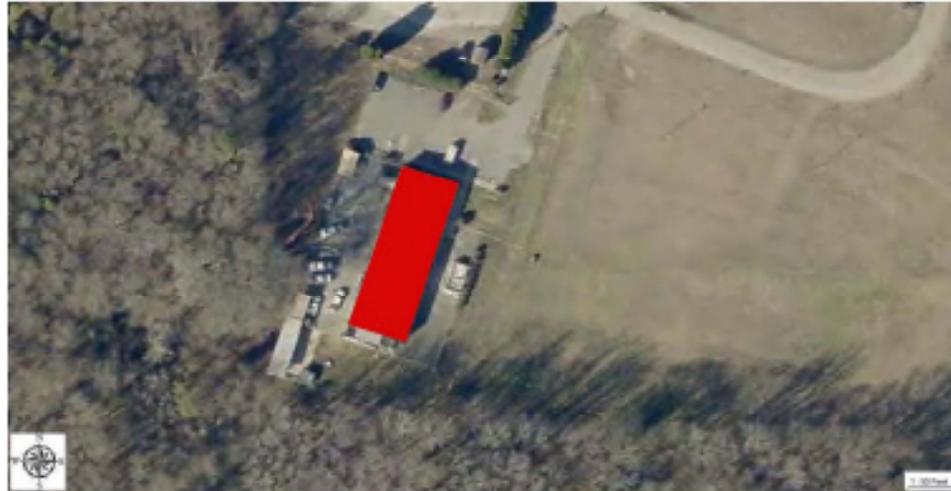
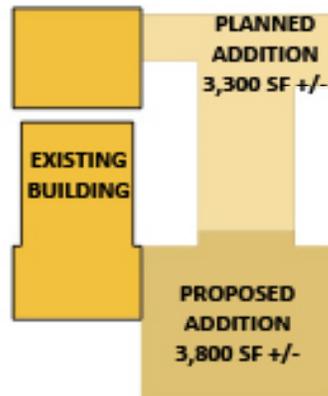
1465 JULIAN ROAD – ANIMAL CONTROL

Projected Construction Cost
555,000 – New Shell Building
(Proposed Addition)
92,000 – Animal Control
647,000 – Sub Total – Shell & Upfit
