1. General Information

1.1 Name: St. Andrew's Episcopal Church and Cemetery

1.2 Address: 1115 St. Andrew's Church, Woodleaf NC, 27054

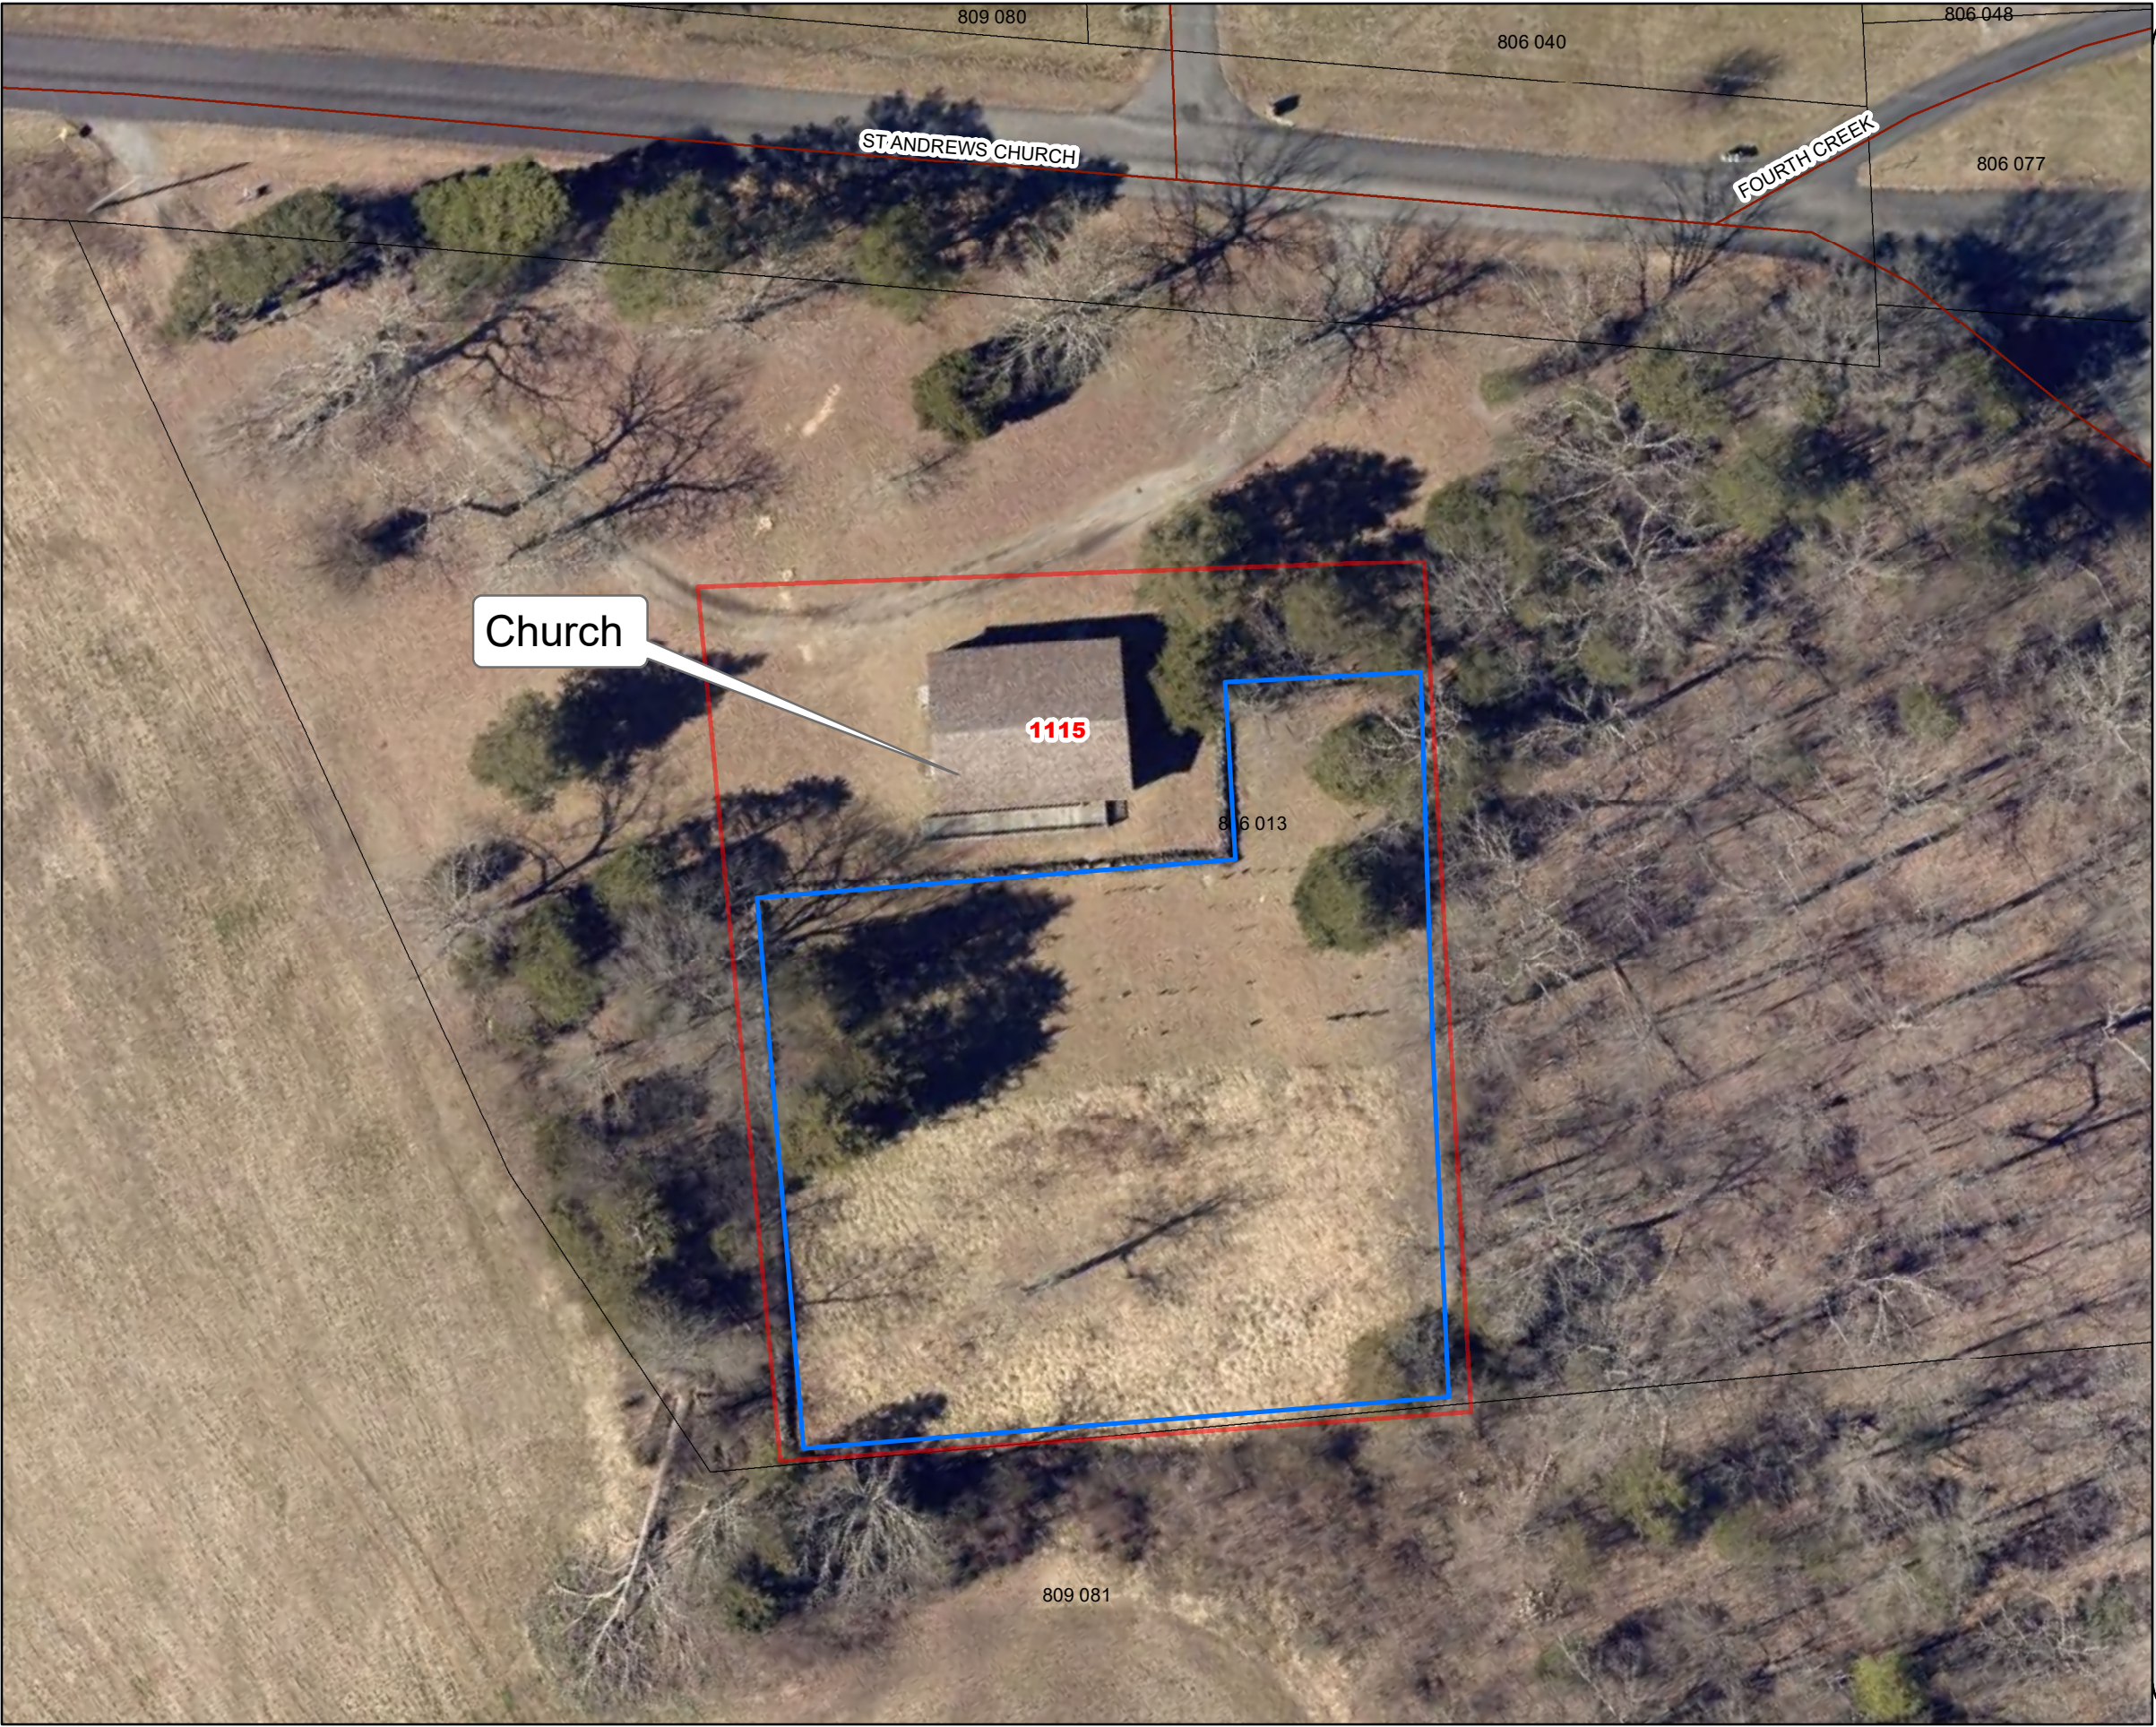
St. Andrews Local Designation Site Plan

See maps and documents provided by the Planning Department that indicate the boundaries of the property and siting of the church and cemetery.

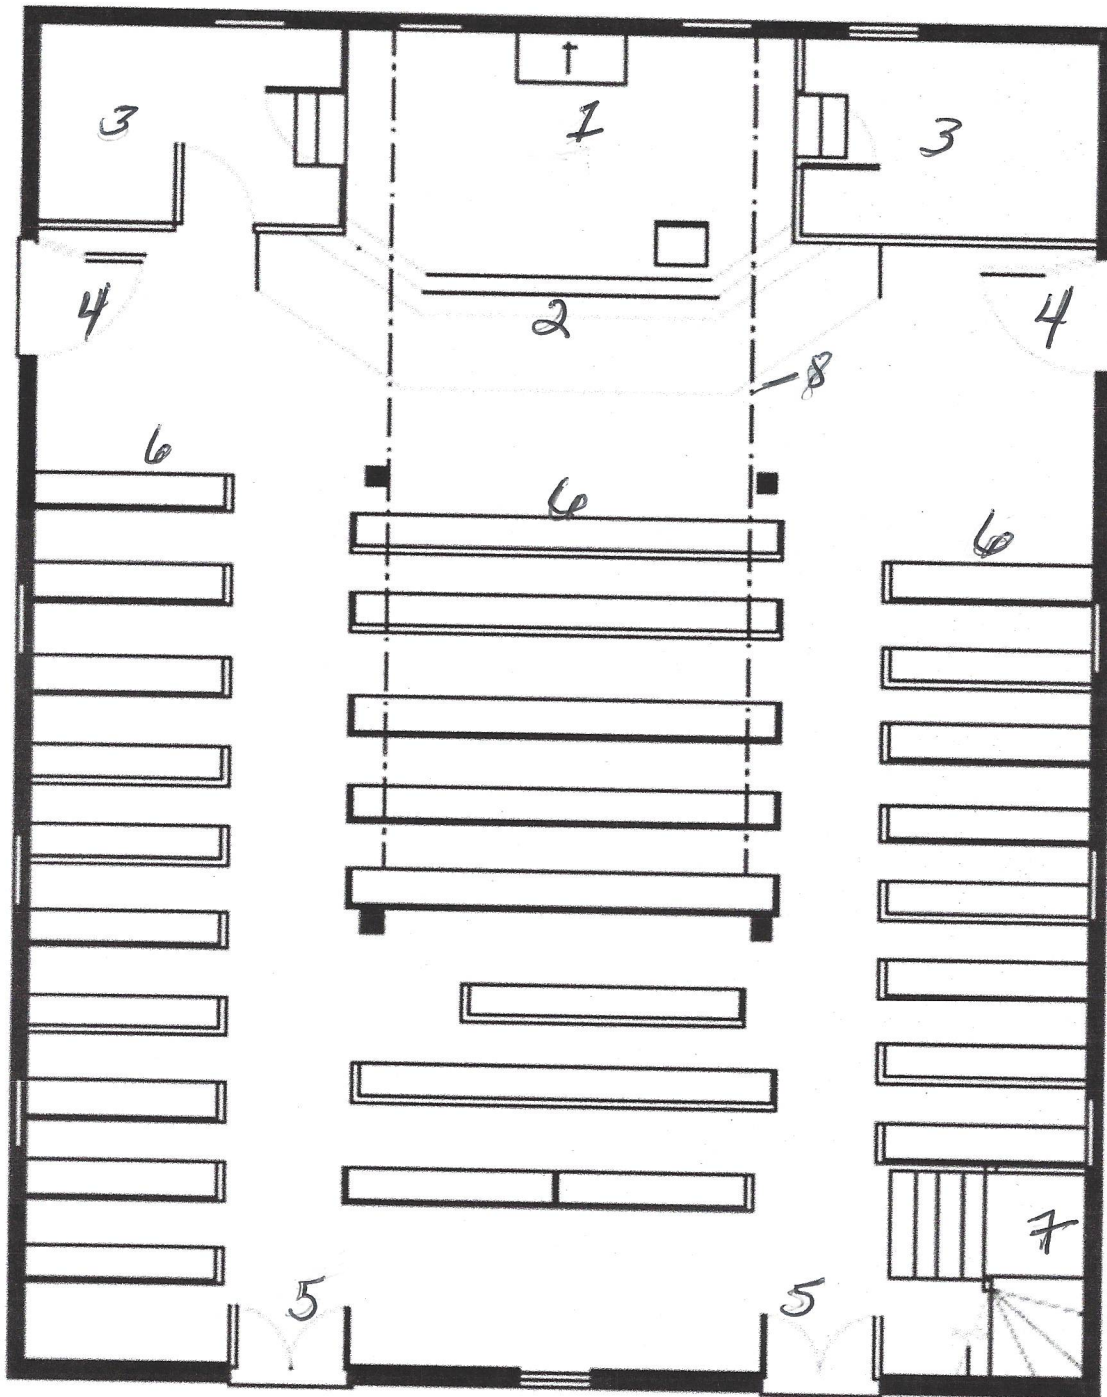
Measured by Carl Lounsbury, Colonial Williamsburg Foundation

Drawn by Evelyn Strobe, Colonial Williamsburg Foundation

- 1) Chancel: Altar and Lectern**
- 2) Communion Rail**
- 3) Anterooms**
- 4) West and East Doors**
- 5) South Doors**
- 6) Pews**
- 7) Stairs to Gallery**
- 8) Broken Line: Superimposed Gallery**

According to Carl Lounsbury of the Colonial Williamsburg Foundation, based on his research into the history of early American churches and meeting houses, St. Andrew's is "a good late example of a plan that was used by Anglicans/Episcopalians as early as 1608 at Jamestown. Nearly 250 years later, traces of that plan with the chancel doors shows up in piedmont North Carolina. I am impressed by its continuity." (Personal Communication, Carl Lounsbury to Lynn Hoke, Archivist, Diocese of North Carolina.) Lounsbury studied the design and measured the church in 2015 and drew the interior design of St. Andrew's which is included in this document.
